**VARIOUS TYPES OF ENGINE LOSSES
(PRIVATE CAR)**

MVSD PRASAD & A. SRINIVAS REDDY

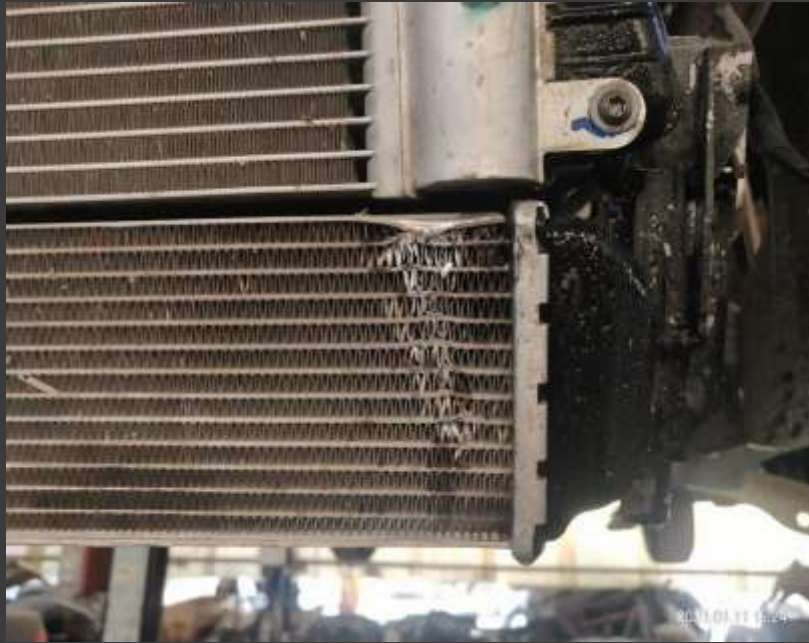
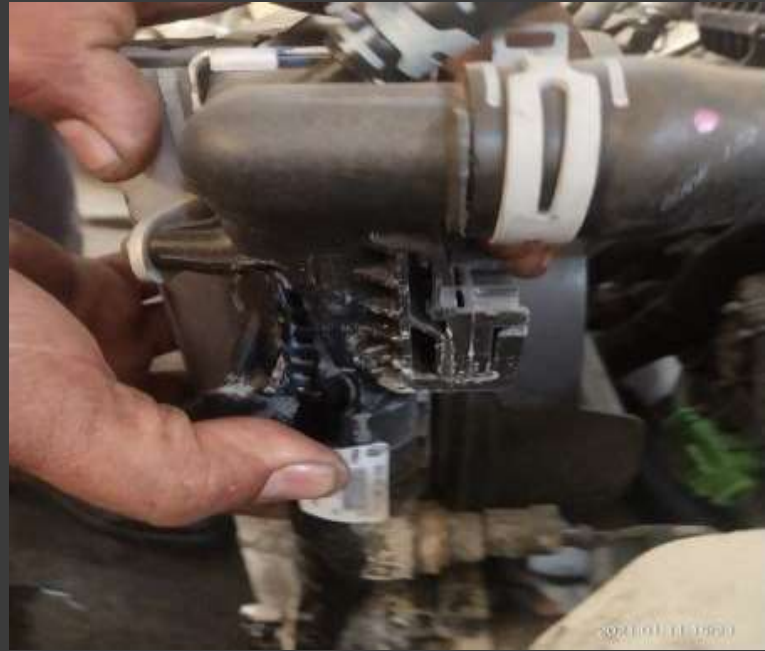
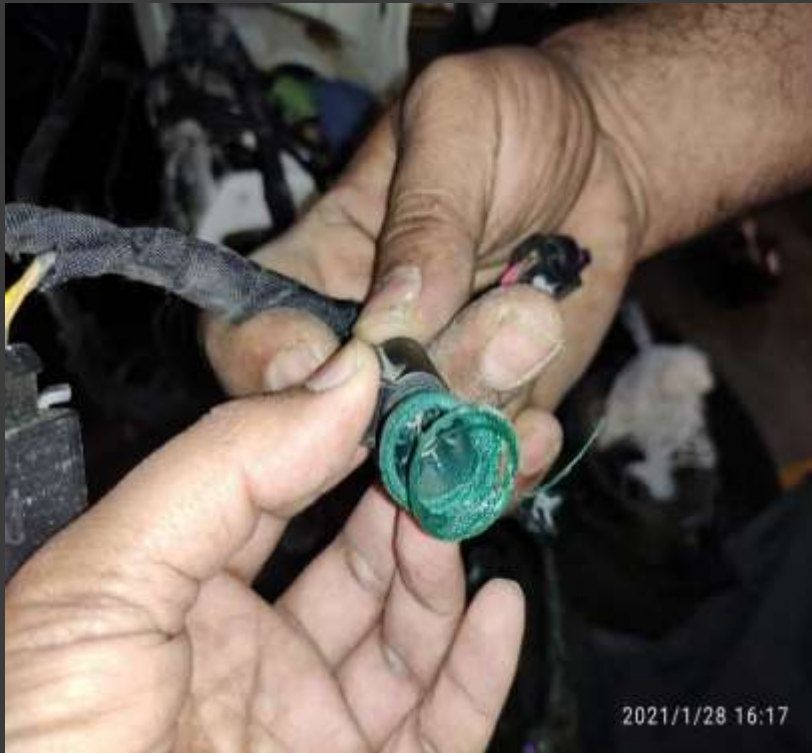
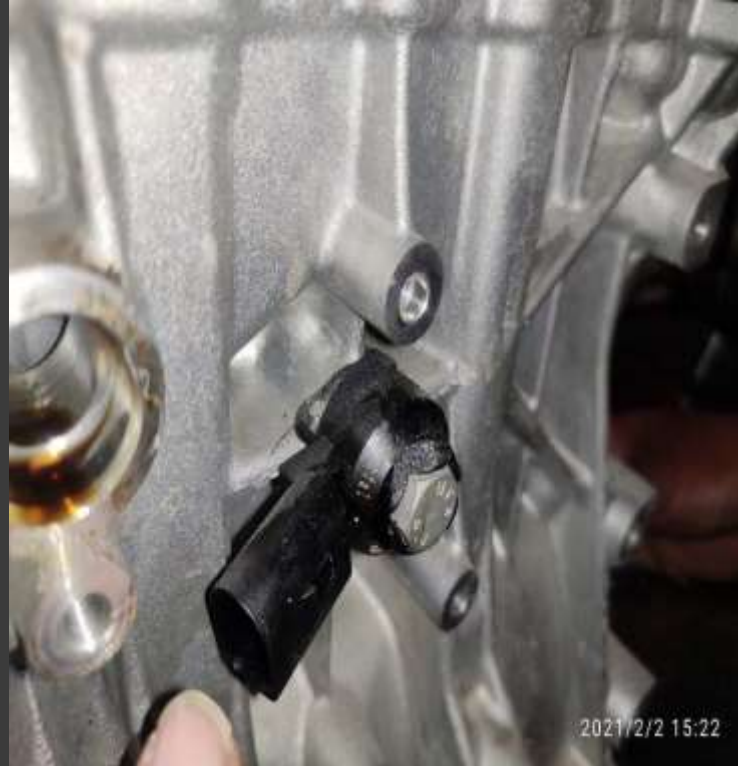
Note: Coolant helps pull heat away from the engine. So, without enough coolant, the engine could overheat or seize up. Continued use of an overheated engine could lead to permanent damage, such as pistons, cylinder walls, head.

● Melted due to over heat

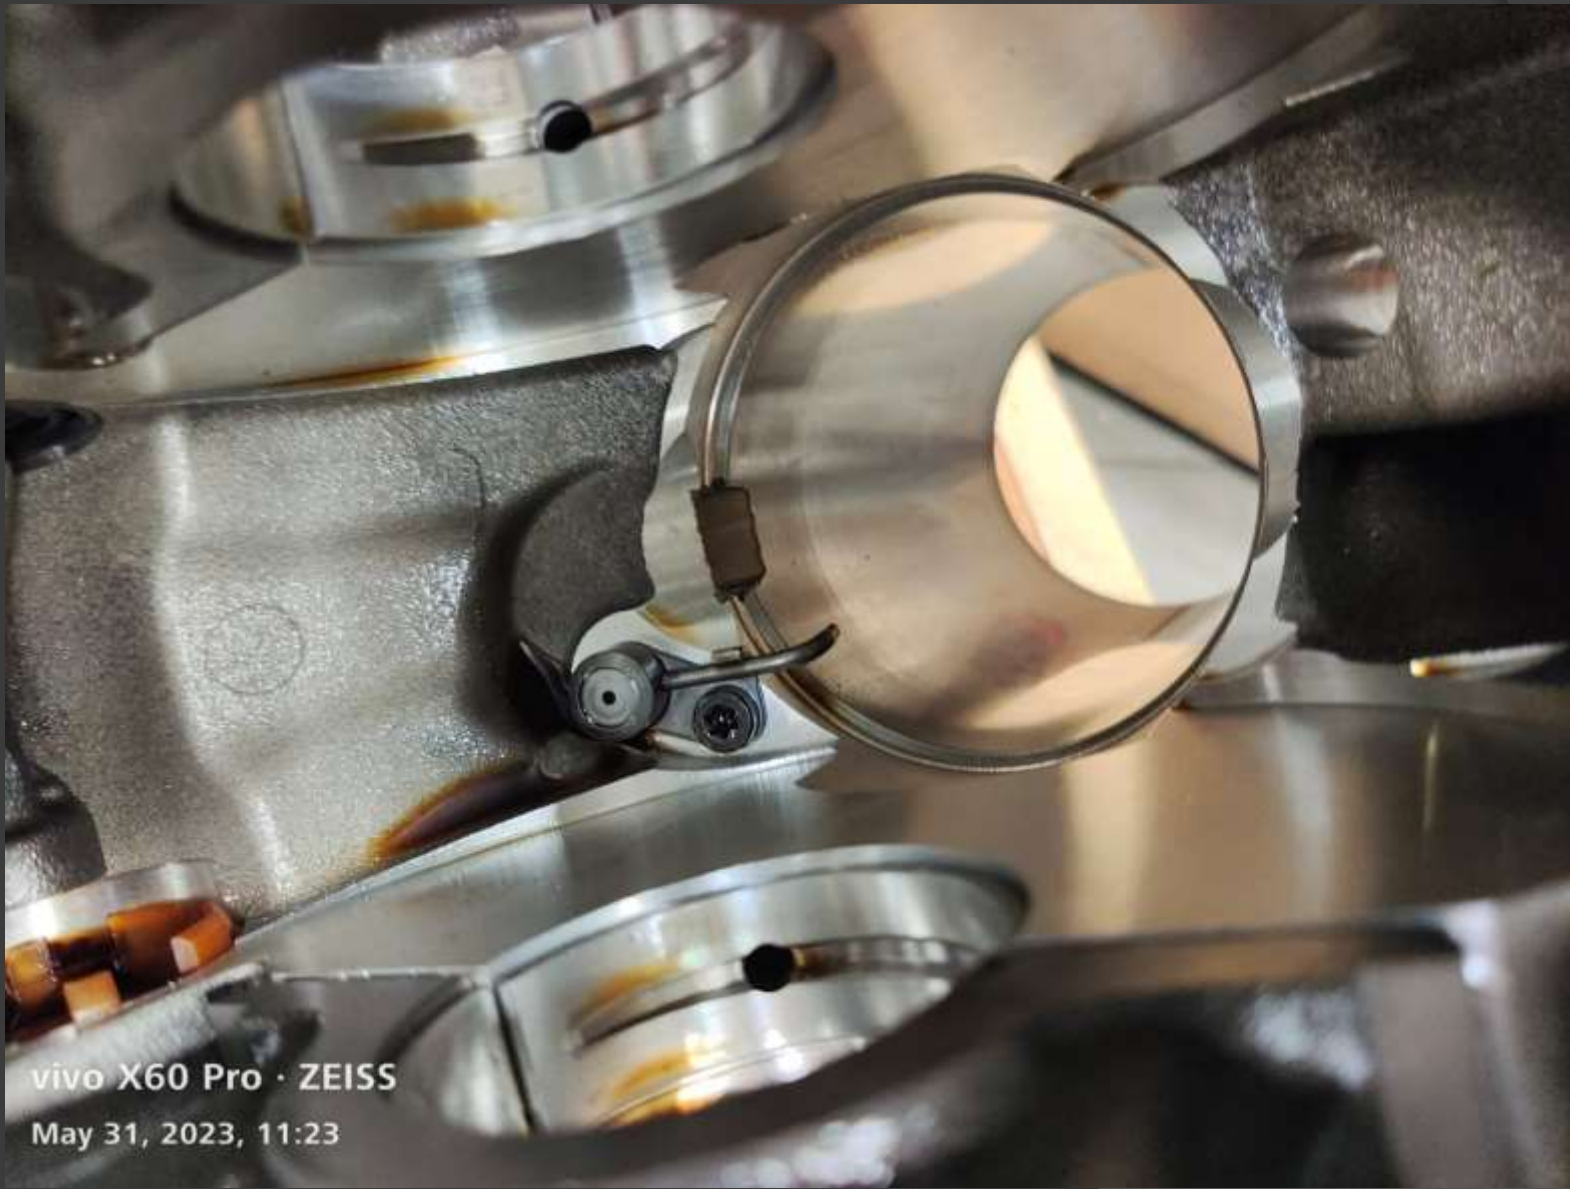
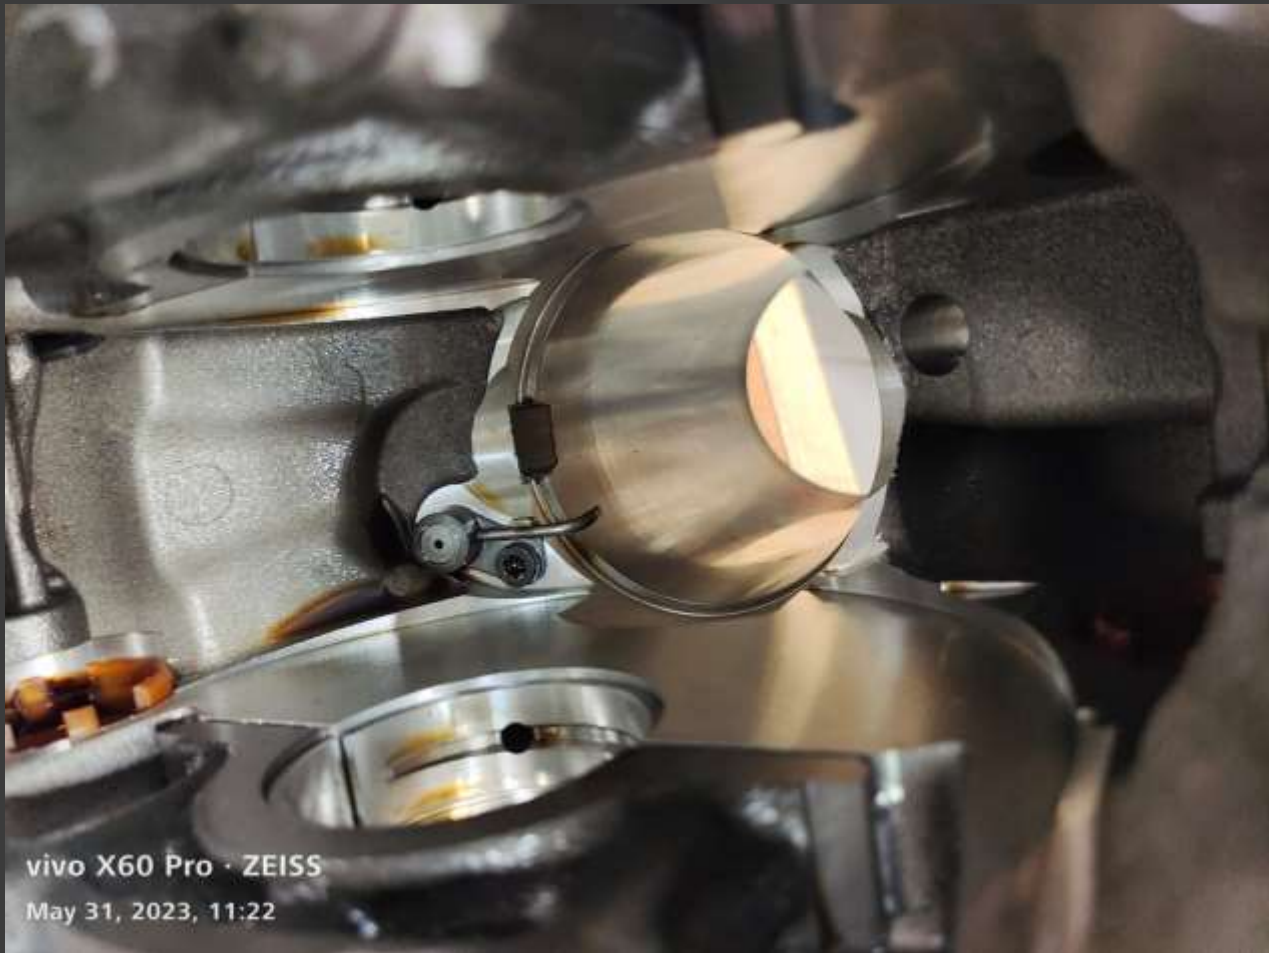
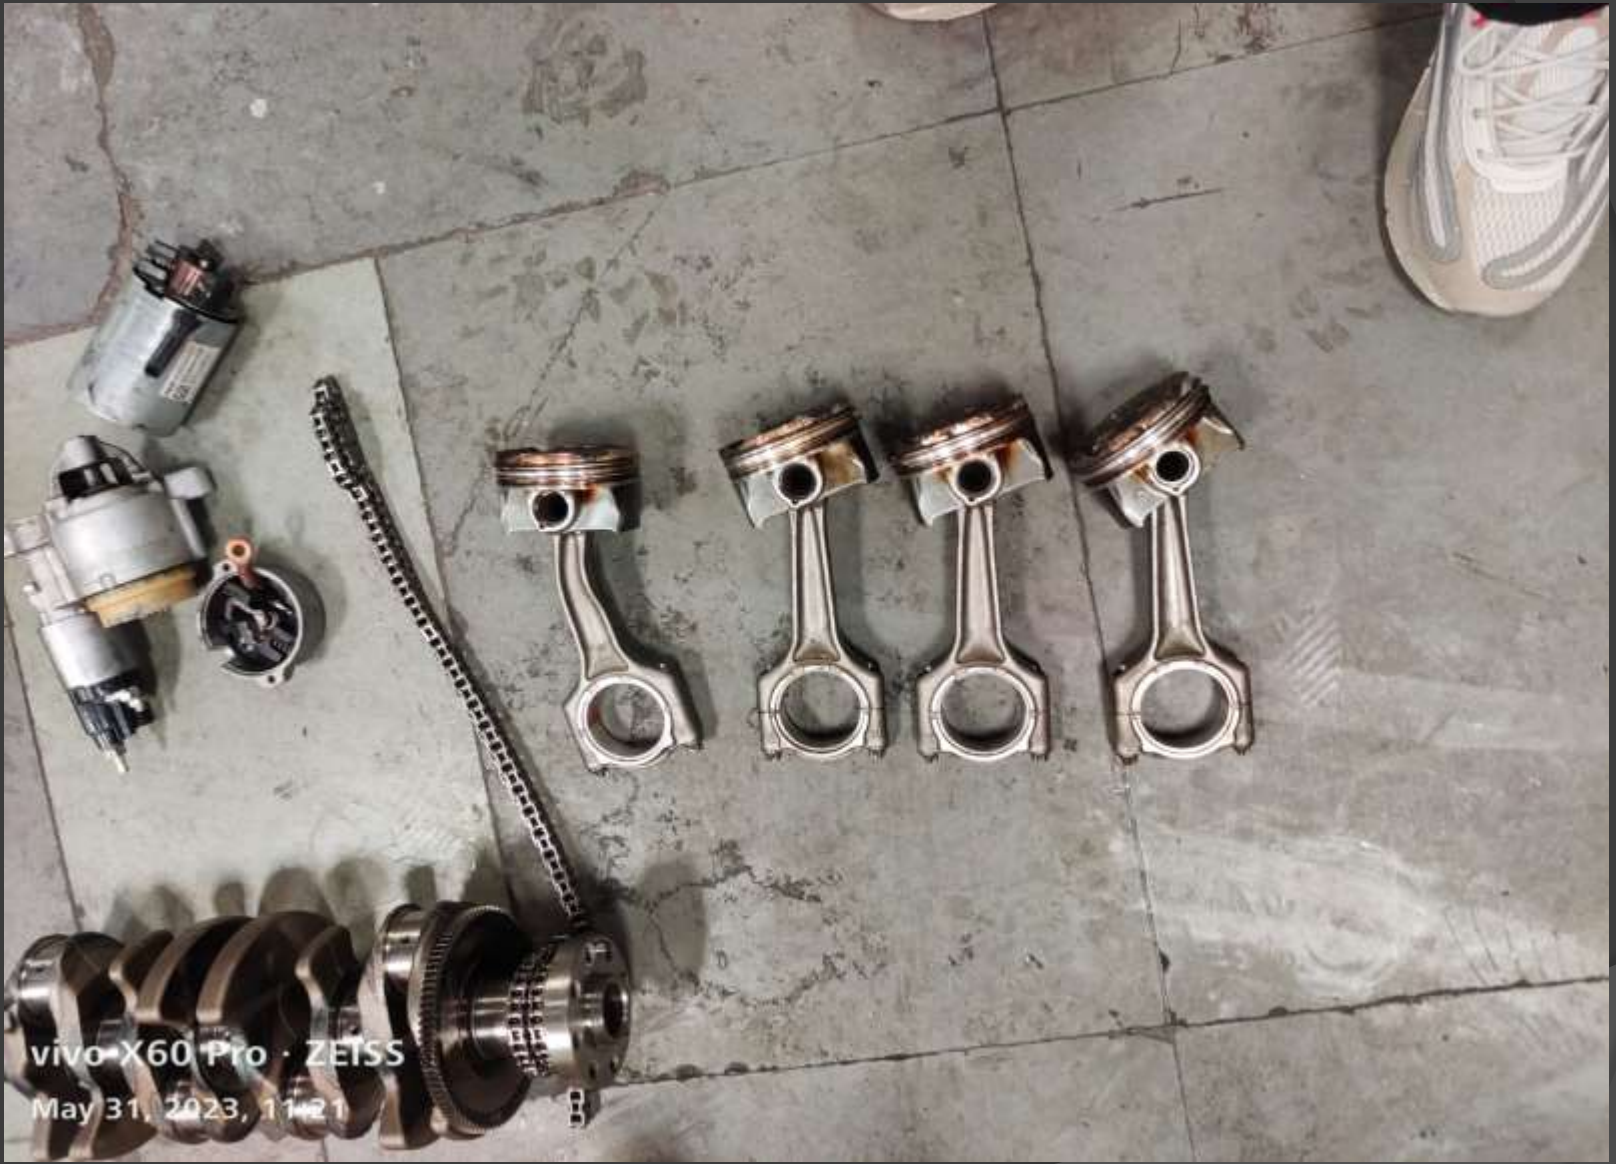
Case study....engine block

- Petrol engine....bent connecting rod tapped the edge of engine block
- We need to check the extent of damage
- How far it is located from BDC
- In few cases, the impact will not be up to BDC/no effect on the compression...we can use the same block if cylinders walls are fine.

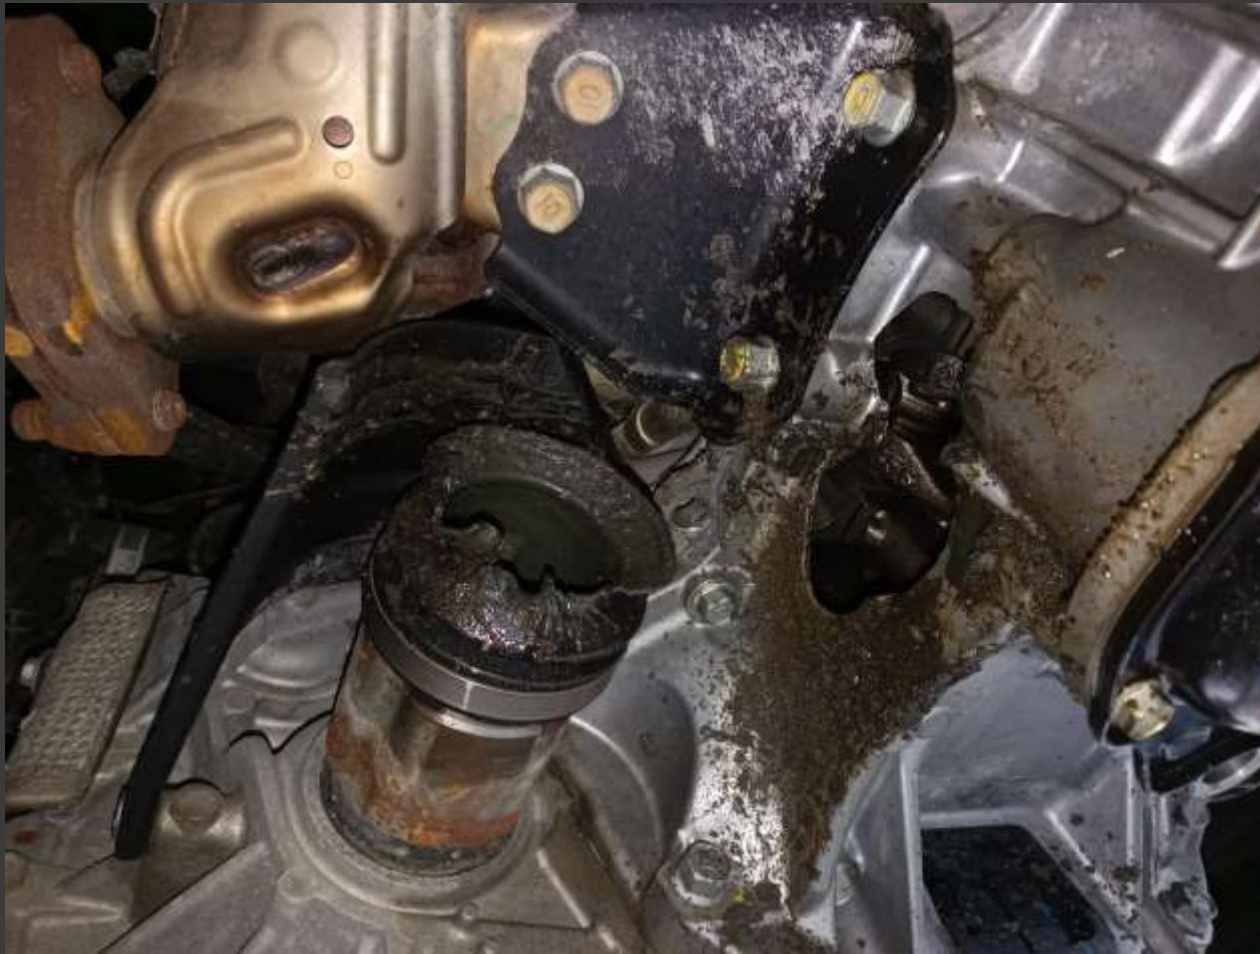
BROKEN BLOCK/CRANK CASE

- ◎ The drive shaft will dislocate and damages the engine block...in such cases, replacing of block with child parts like gasket kit, piston rings, etc.
- ◎ Now a days, the short block is economical than the child parts..we need to check the parts catalog

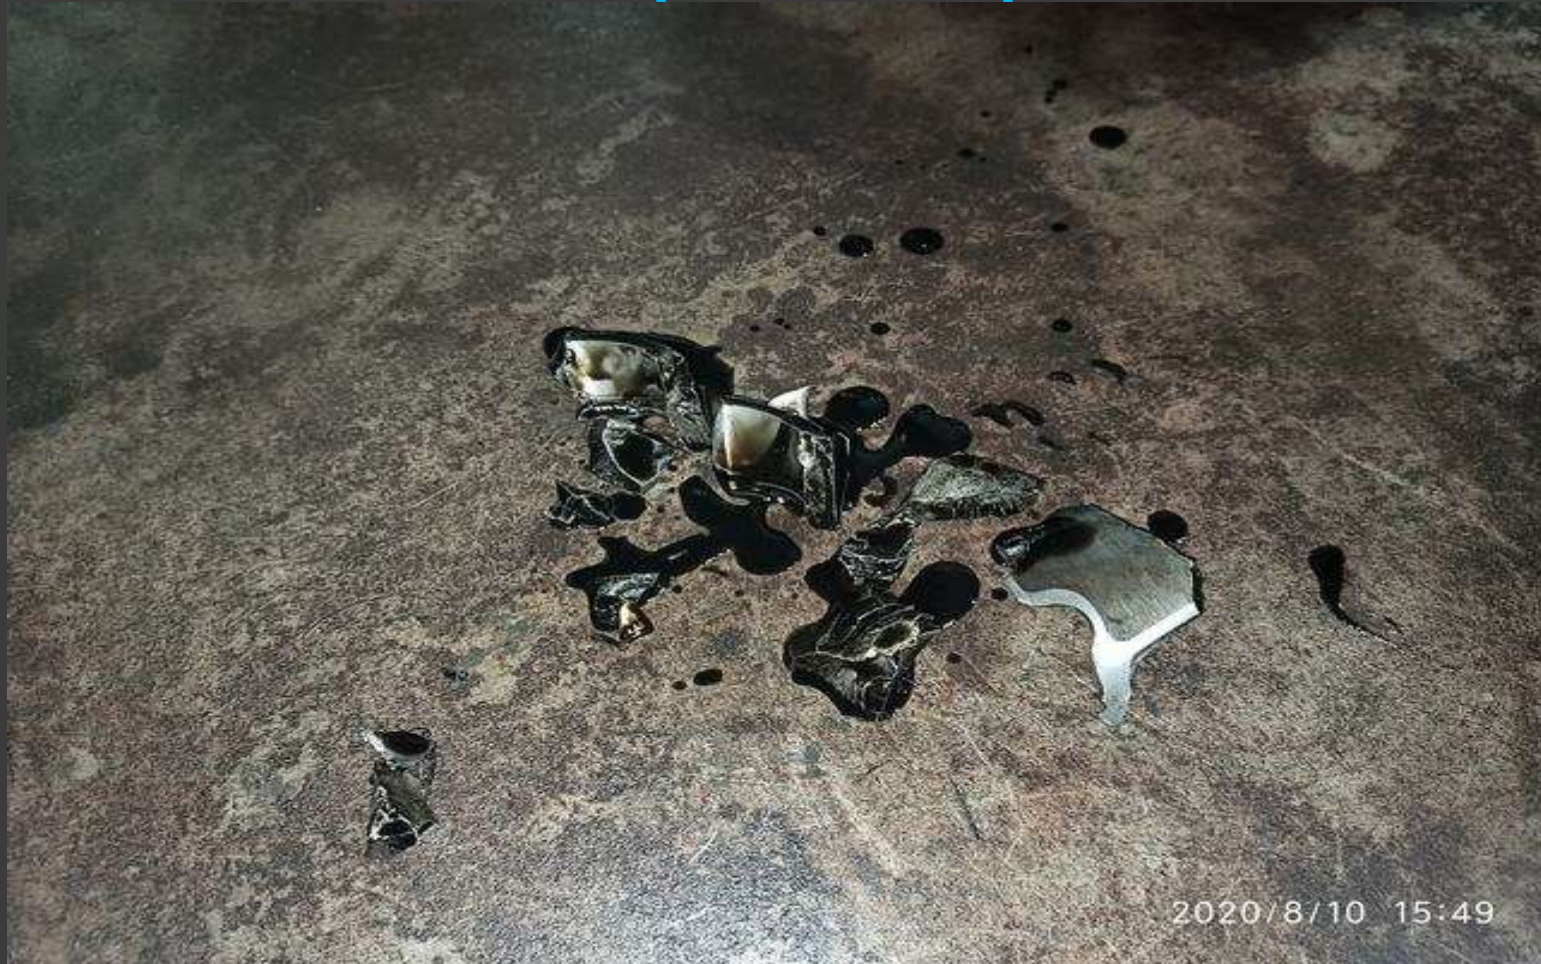
Broken piston pieces

- ⦿ A hydrostatic lock engine flushed and delivered without checking properly
- ⦿ The engine will run smoothly up to certain rpm/up to sustainable rpm and internal damage will occur...like breakage of piston/breakage of connecting rod/engine bore scoring
