**VARIOUS TYPES OF ENGINE LOSSES
(PRIVATE CAR)**

MVSD PRASAD & A. SRINIVAS REDDY

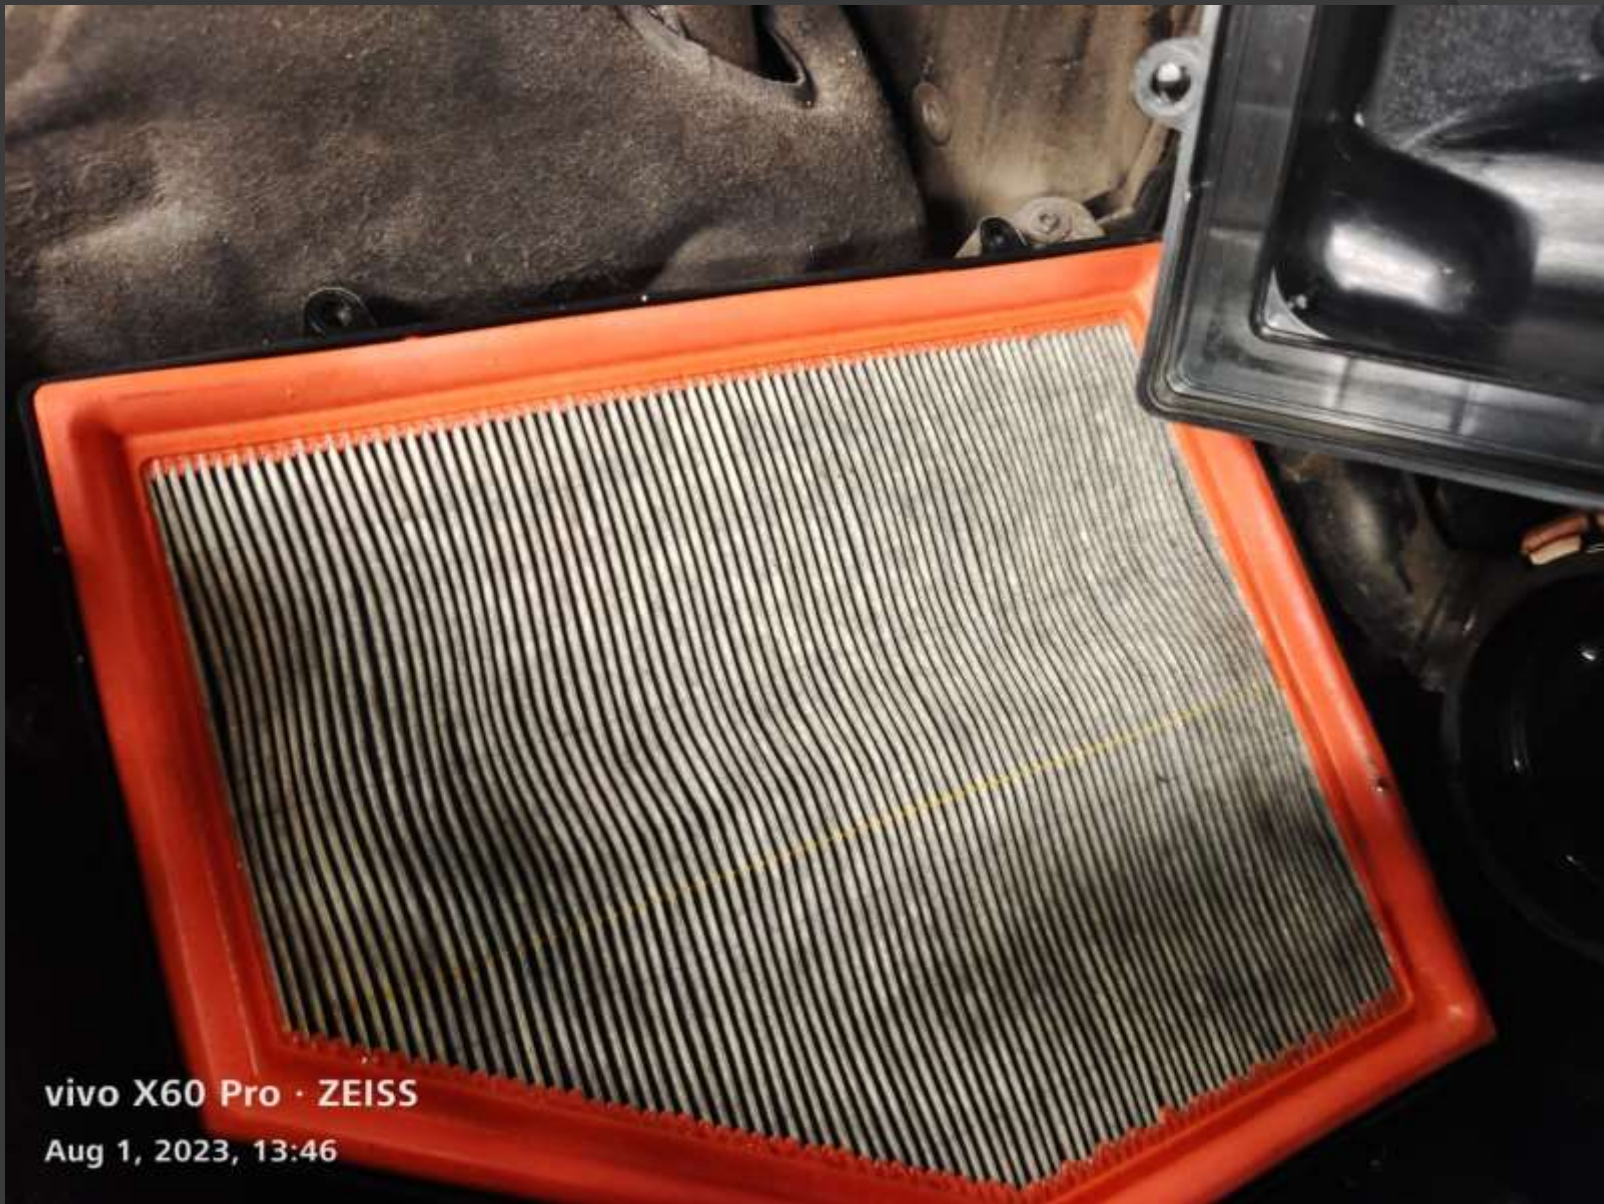
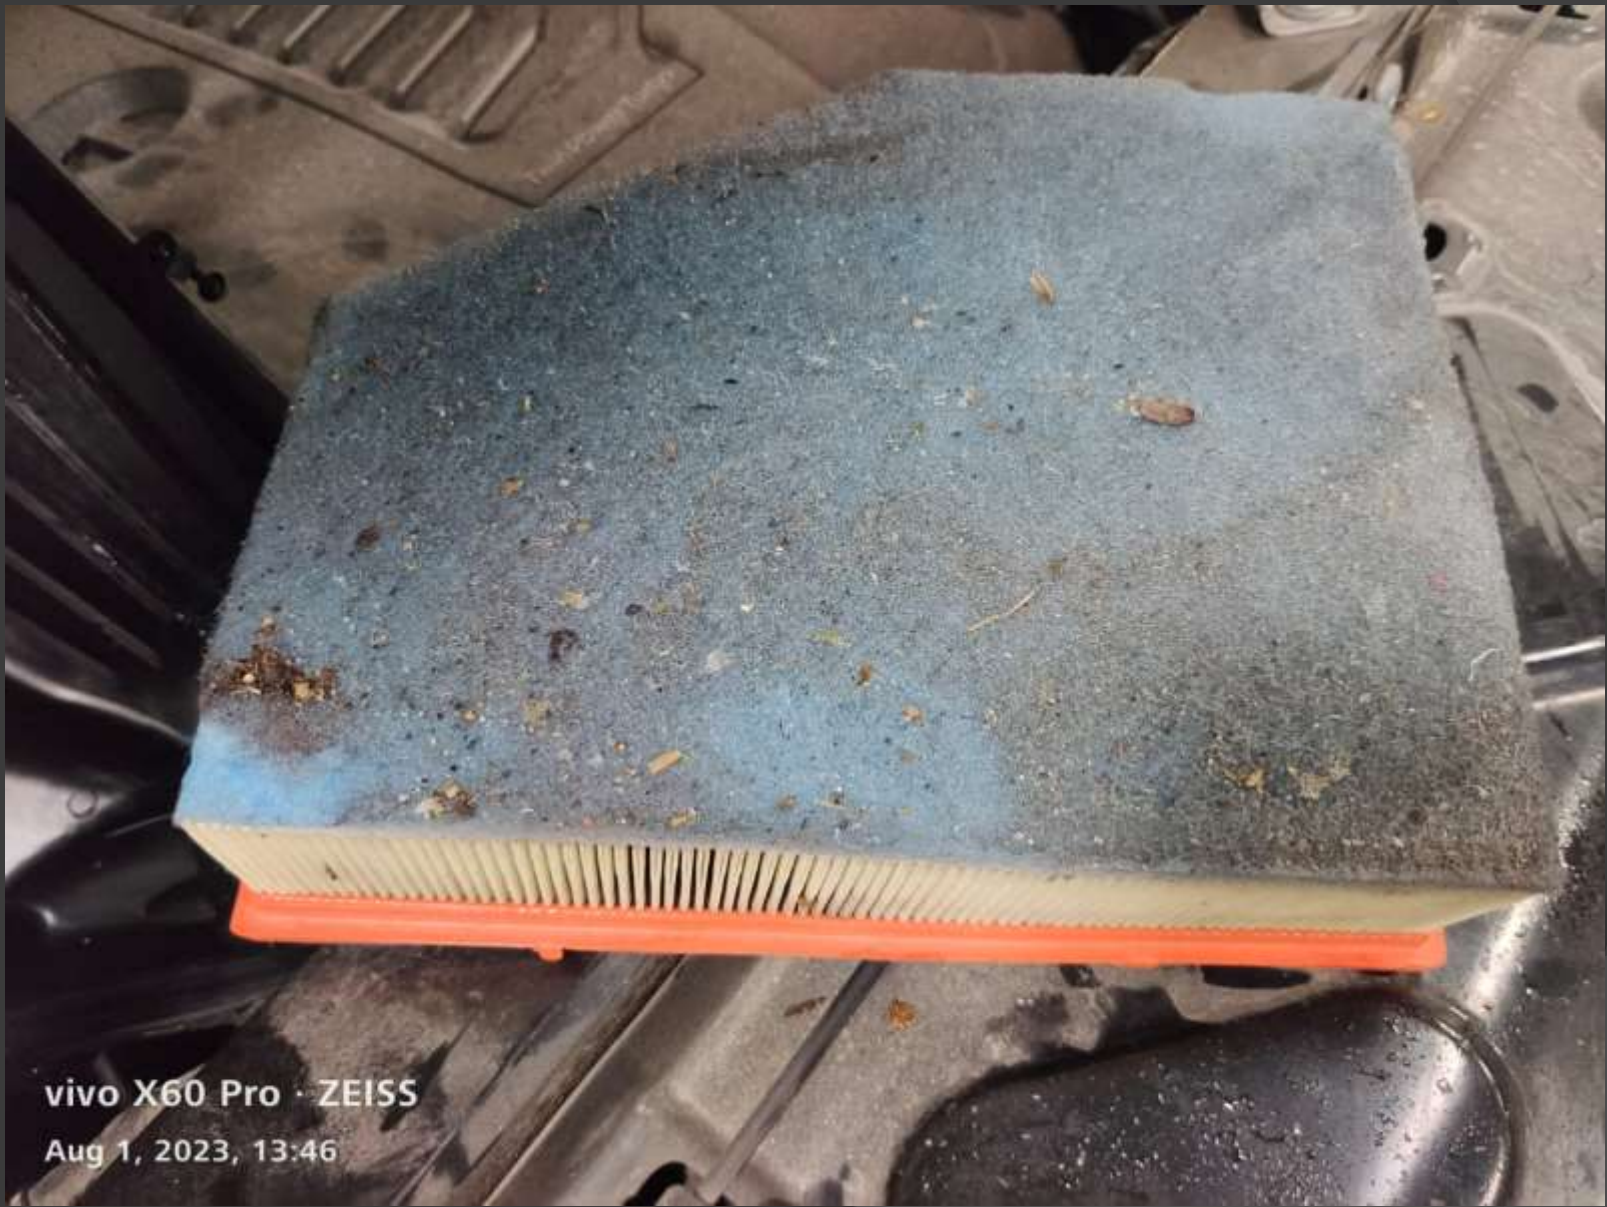
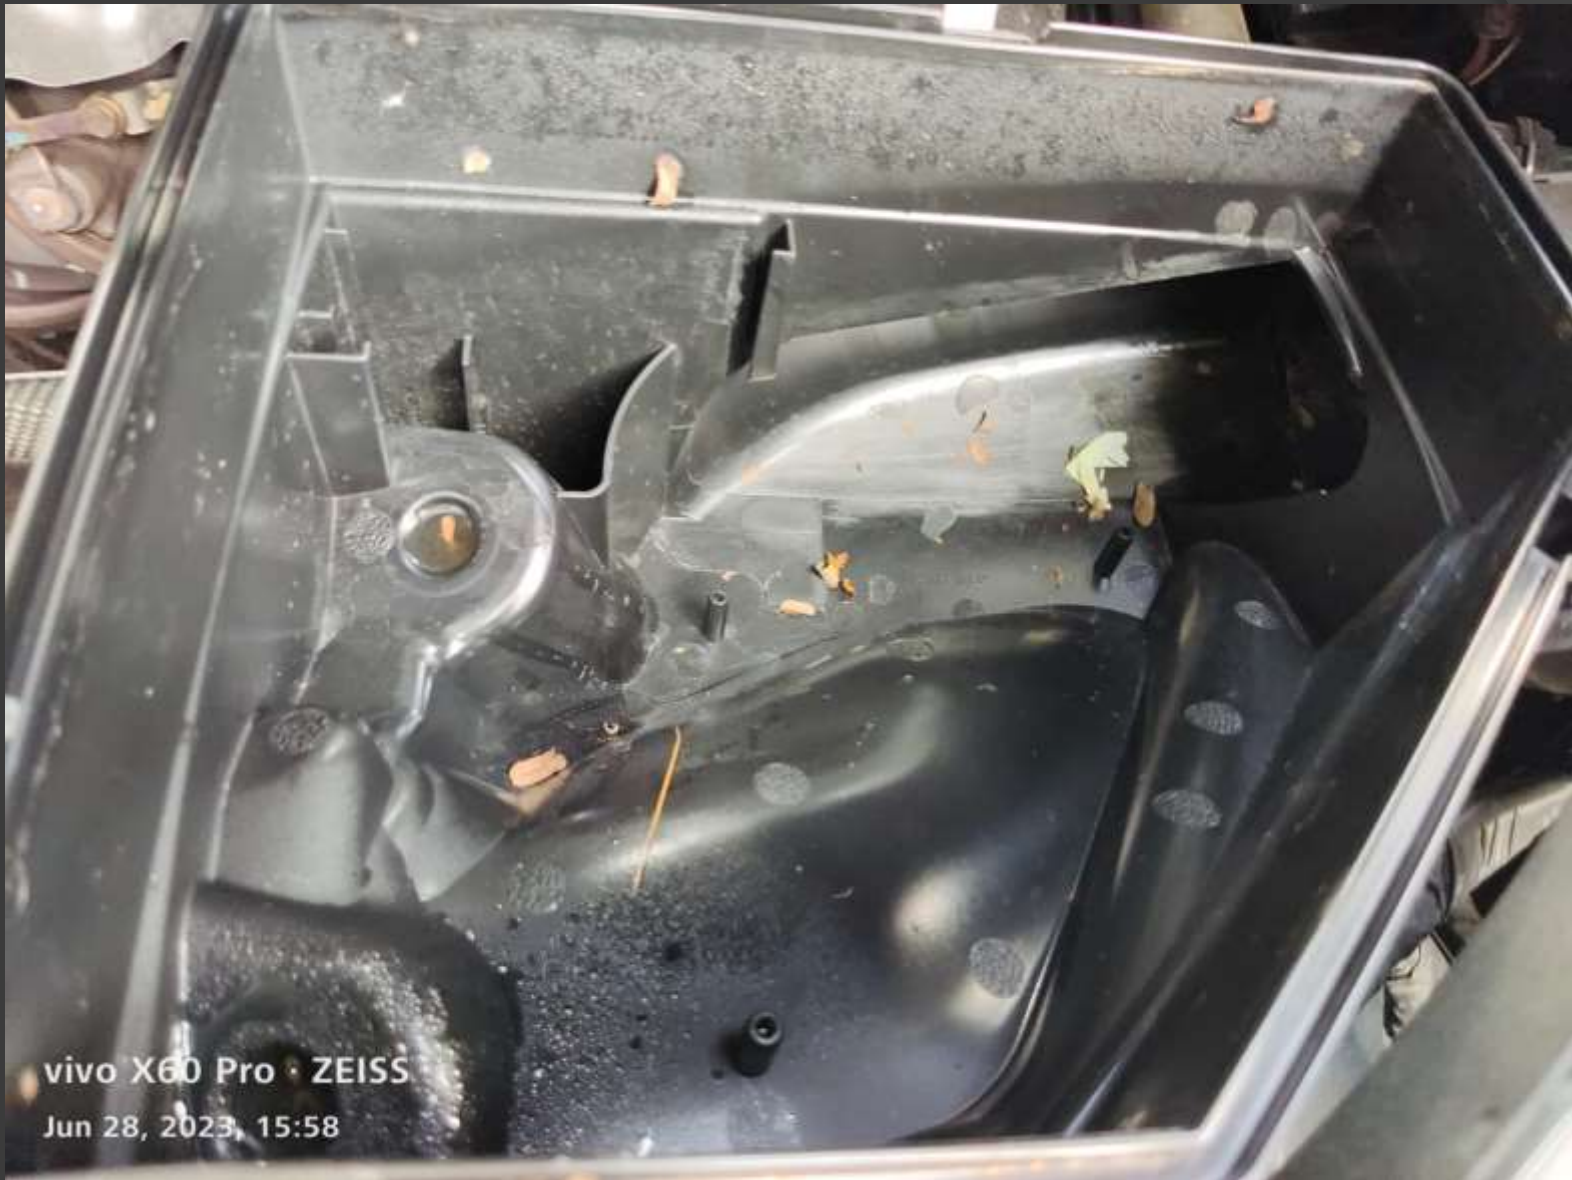
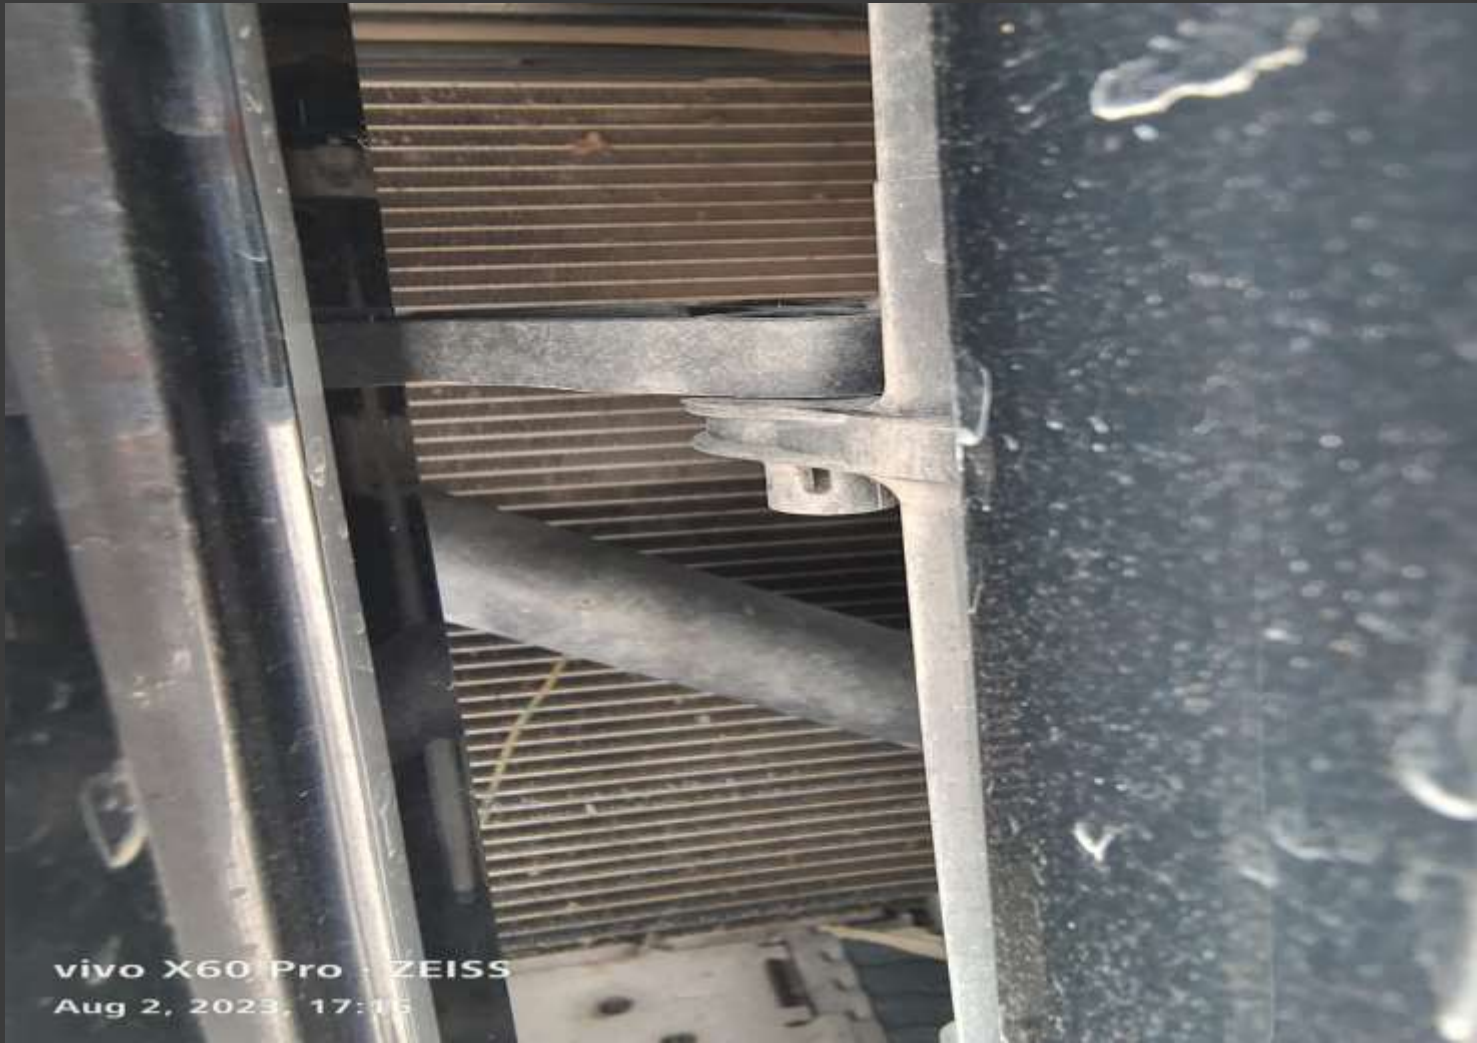
How to Identify the Hydrostatic lock:

- ⦿ Check the air filter for water entry.
- ⦿ Check the water entry into the Engine by checking the oil level gauge.
- ⦿ Drain the Engine oil from the sump -check for water mix.
- ⦿ Try to rotate the crank shaft manually.
- ⦿ If the crank rotates 360°, then flushing of water is advisable. Then go for compression test. If the values are within the recommended range, then the engine is safe.
- ⦿ Counter check -Cold start of engine should be a mandate check in this case for engine idle performance.
- ⦿ If the manual cranking fails, there could be a connecting rod bend. At this stage dismantling of engine would be suggestable.

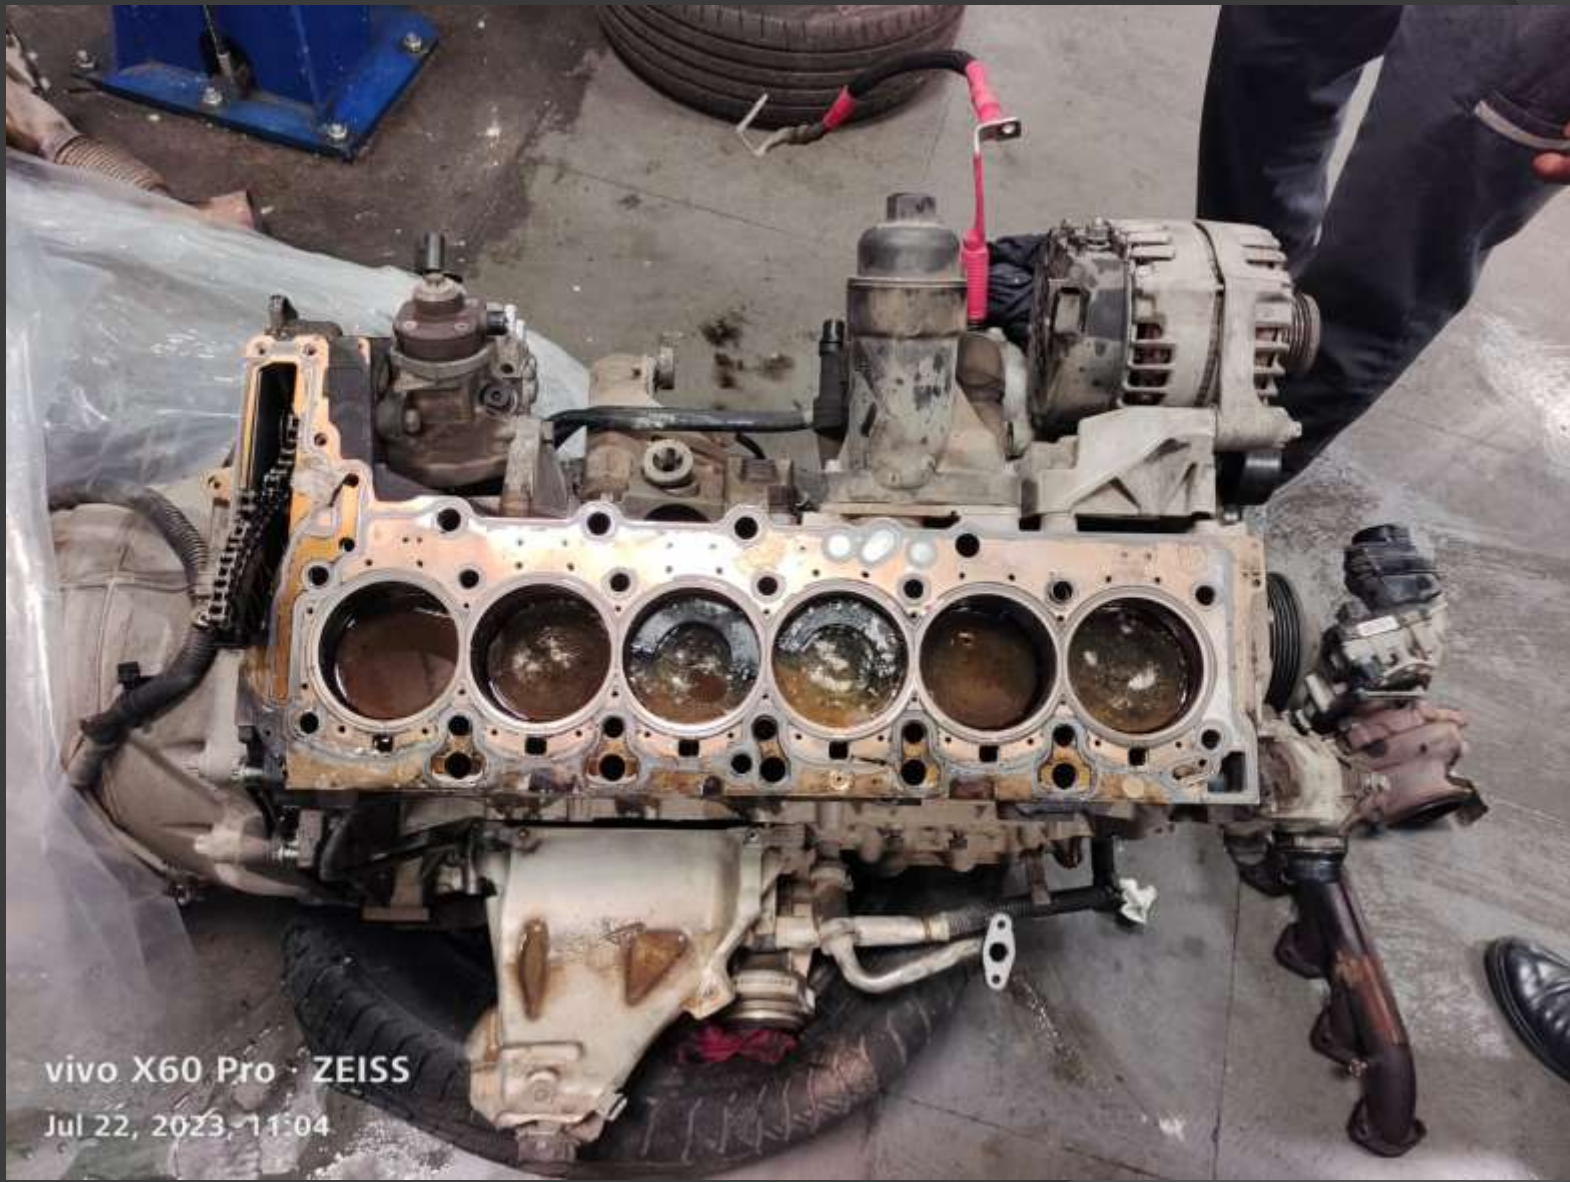
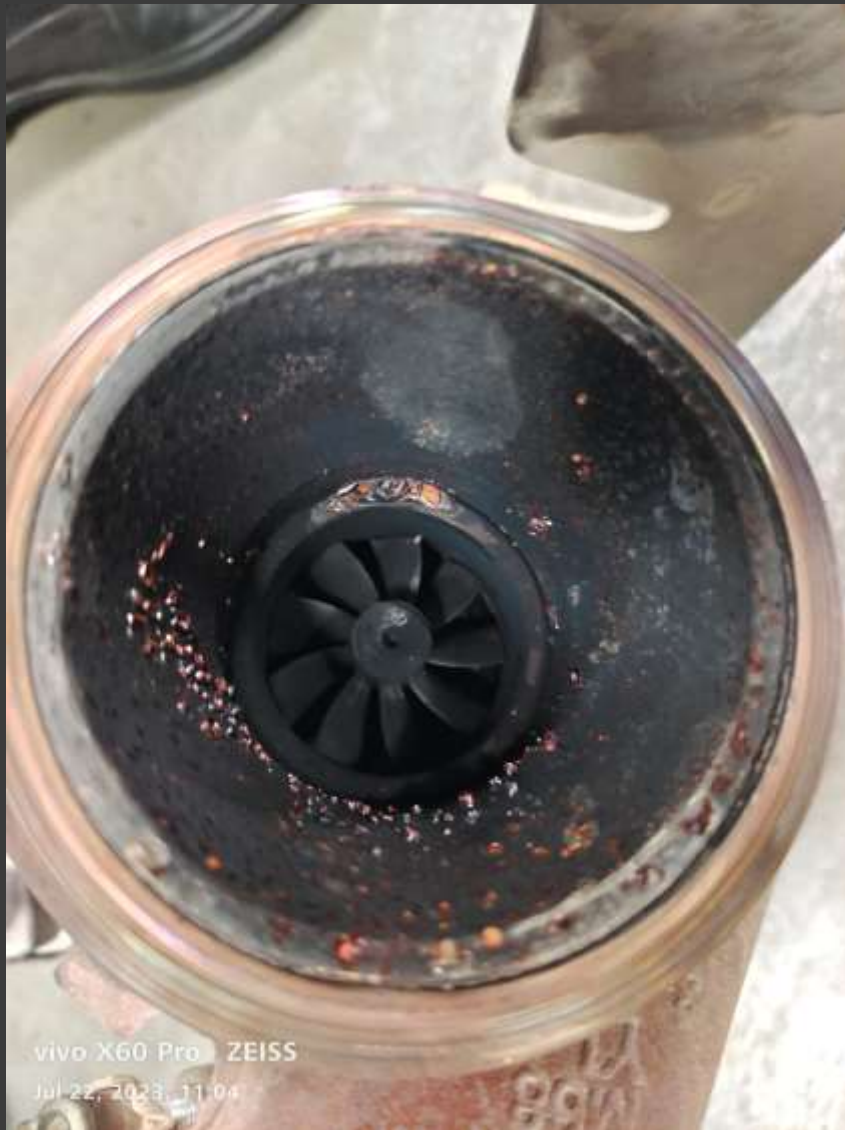
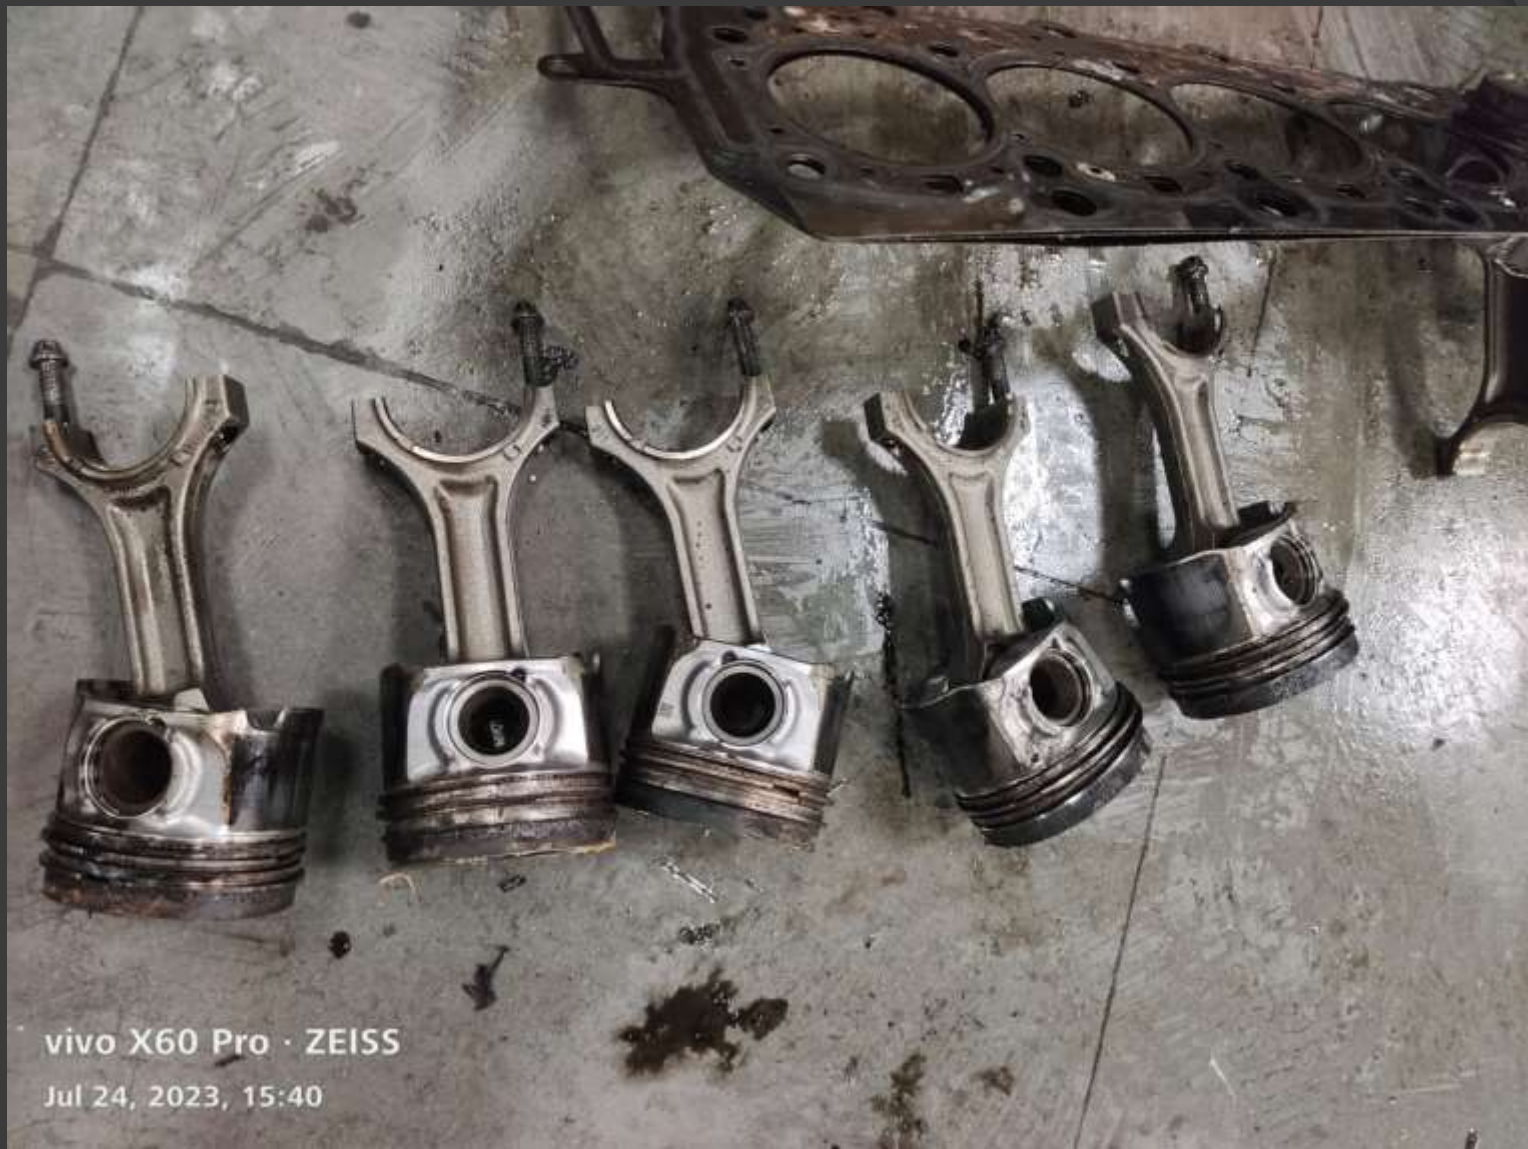
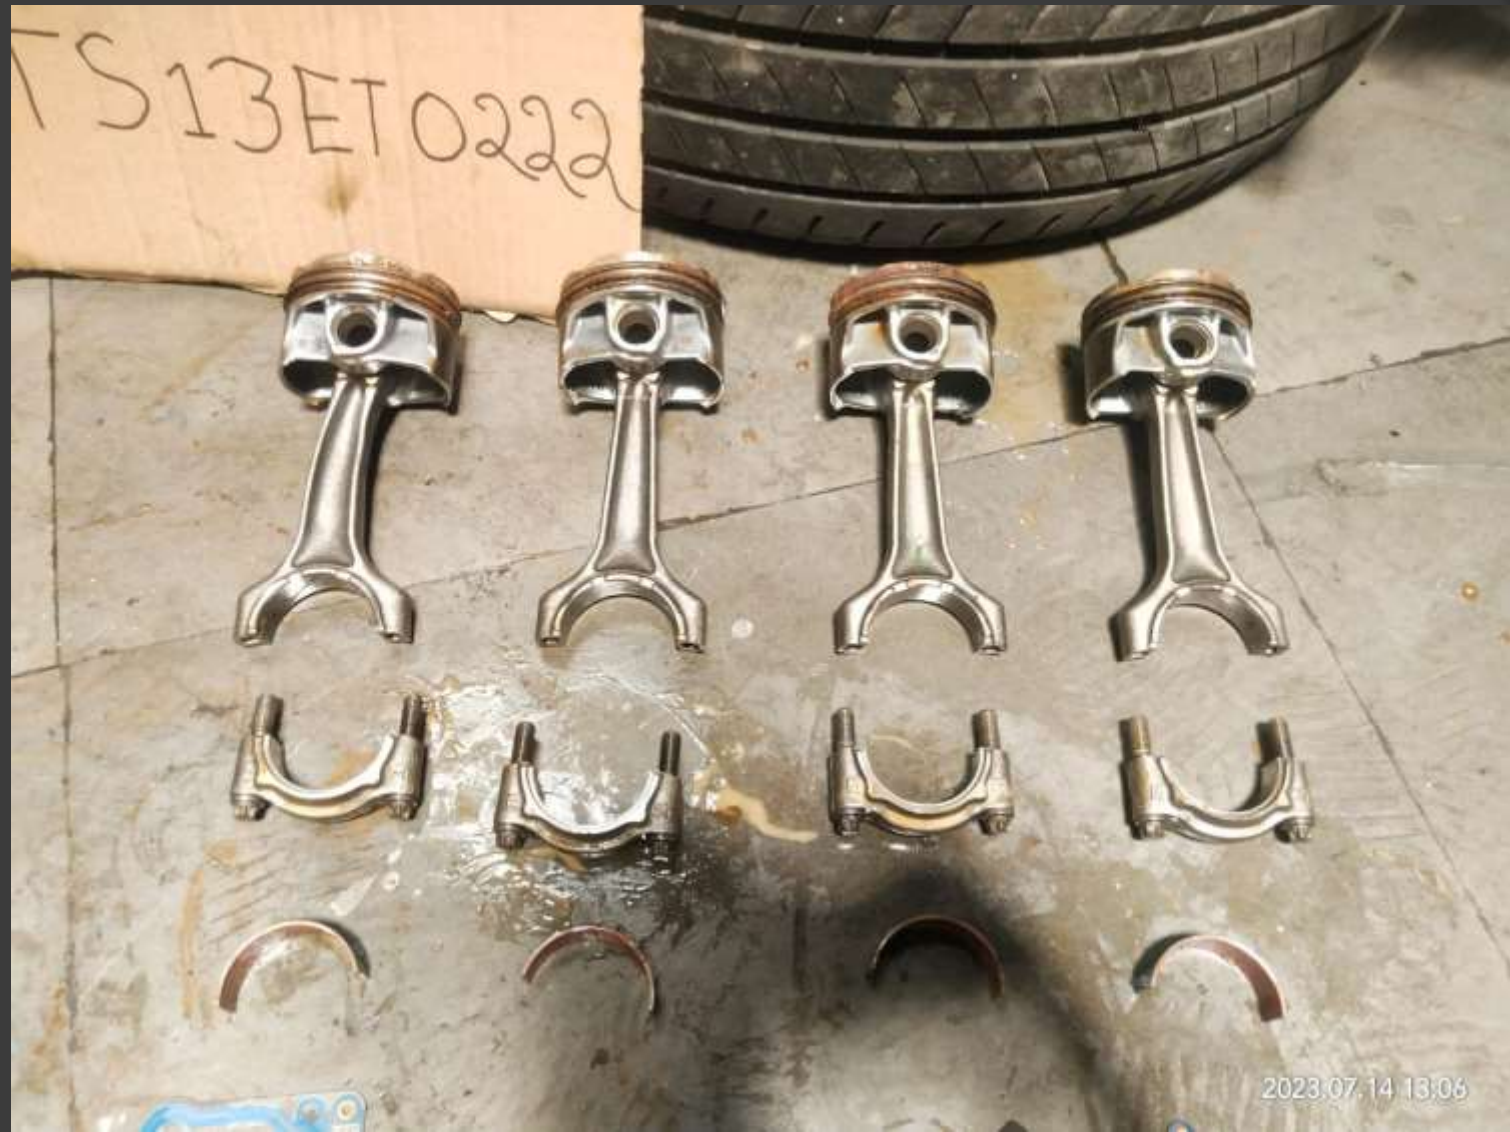
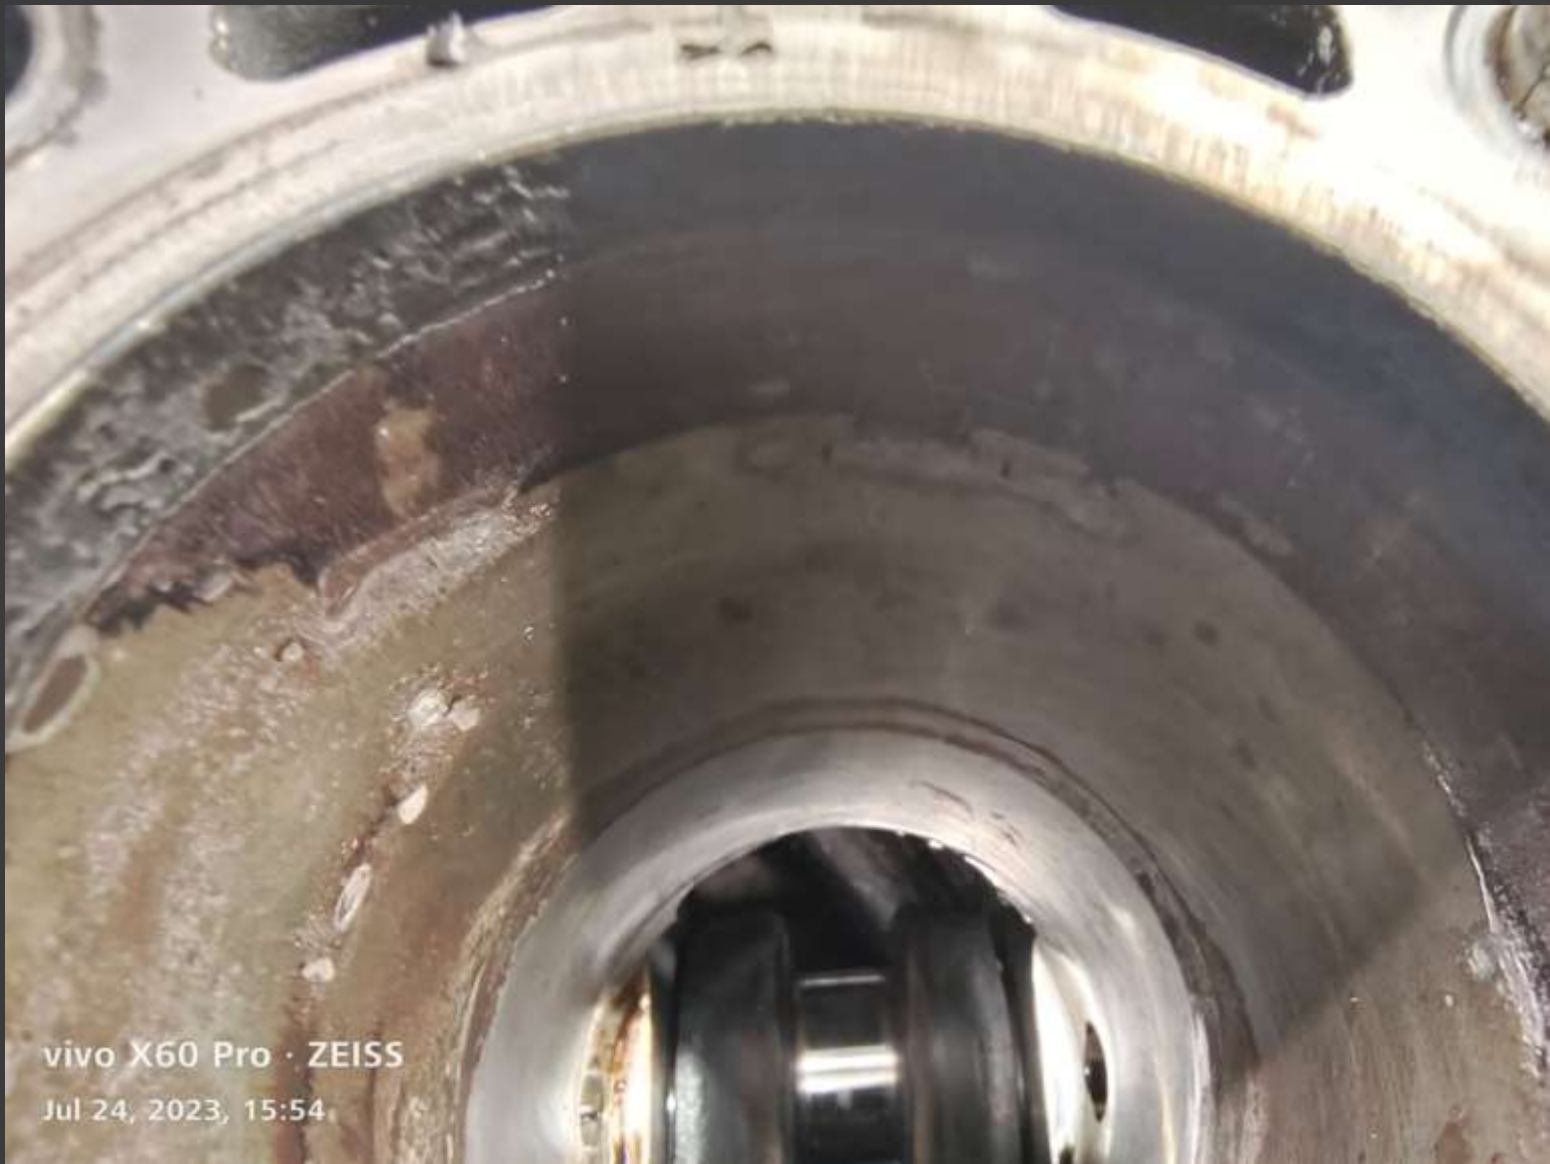
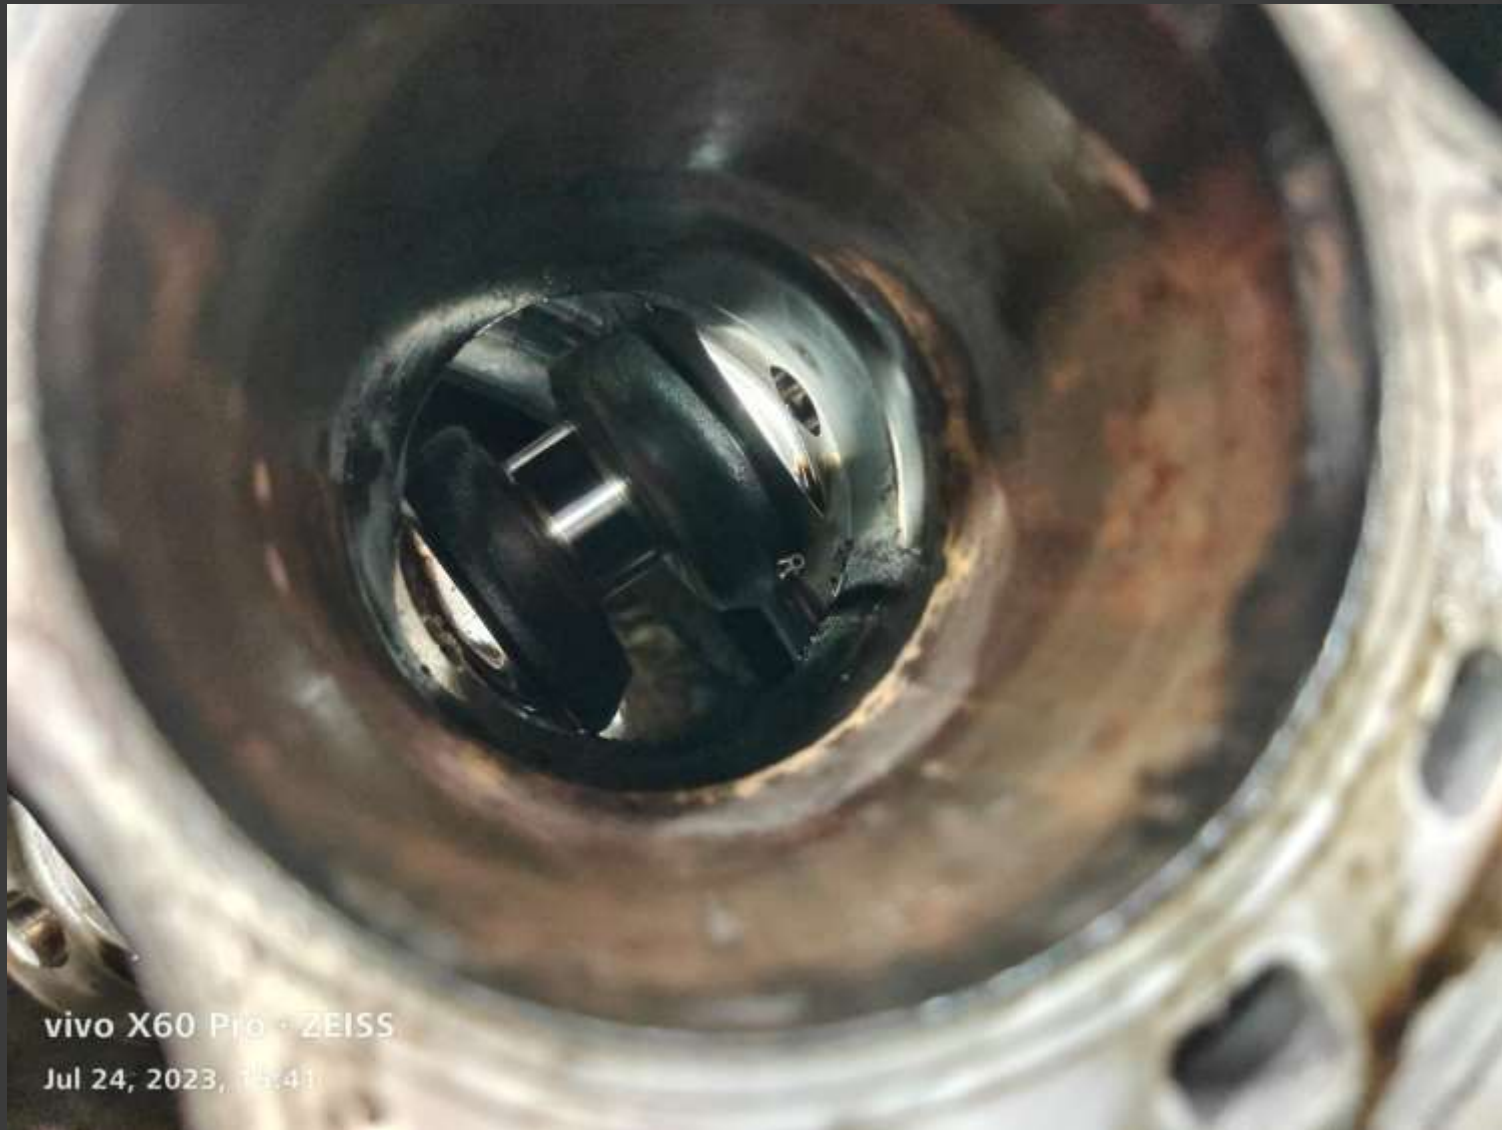
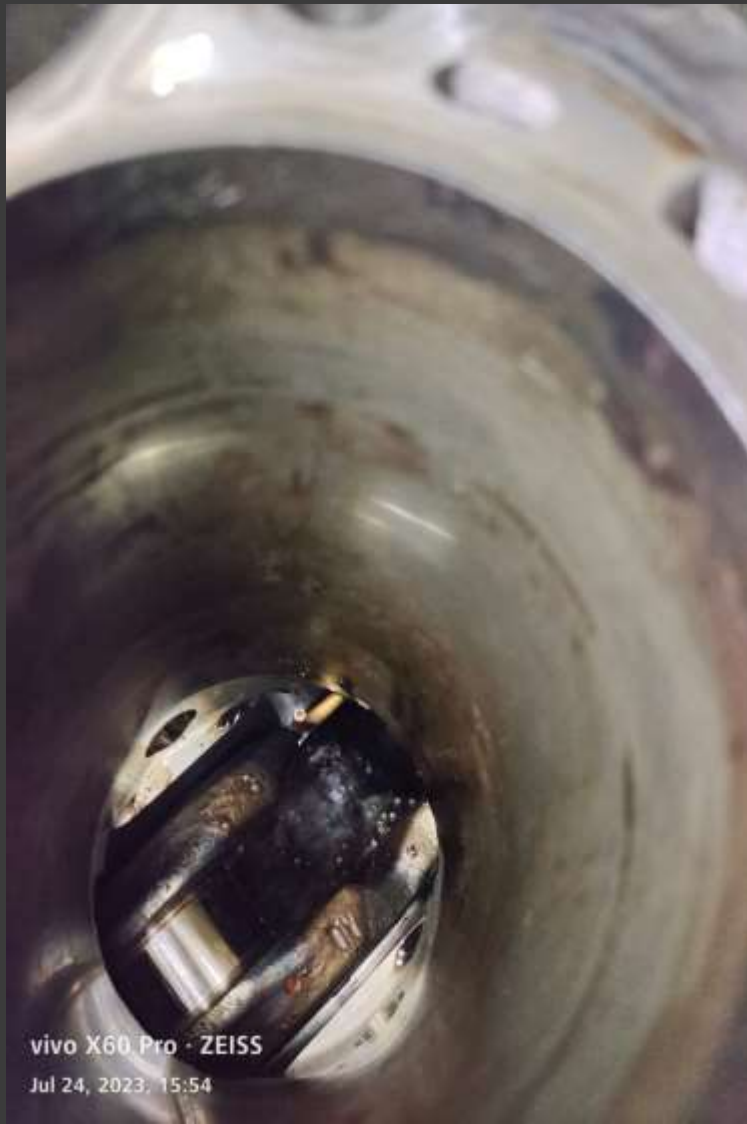
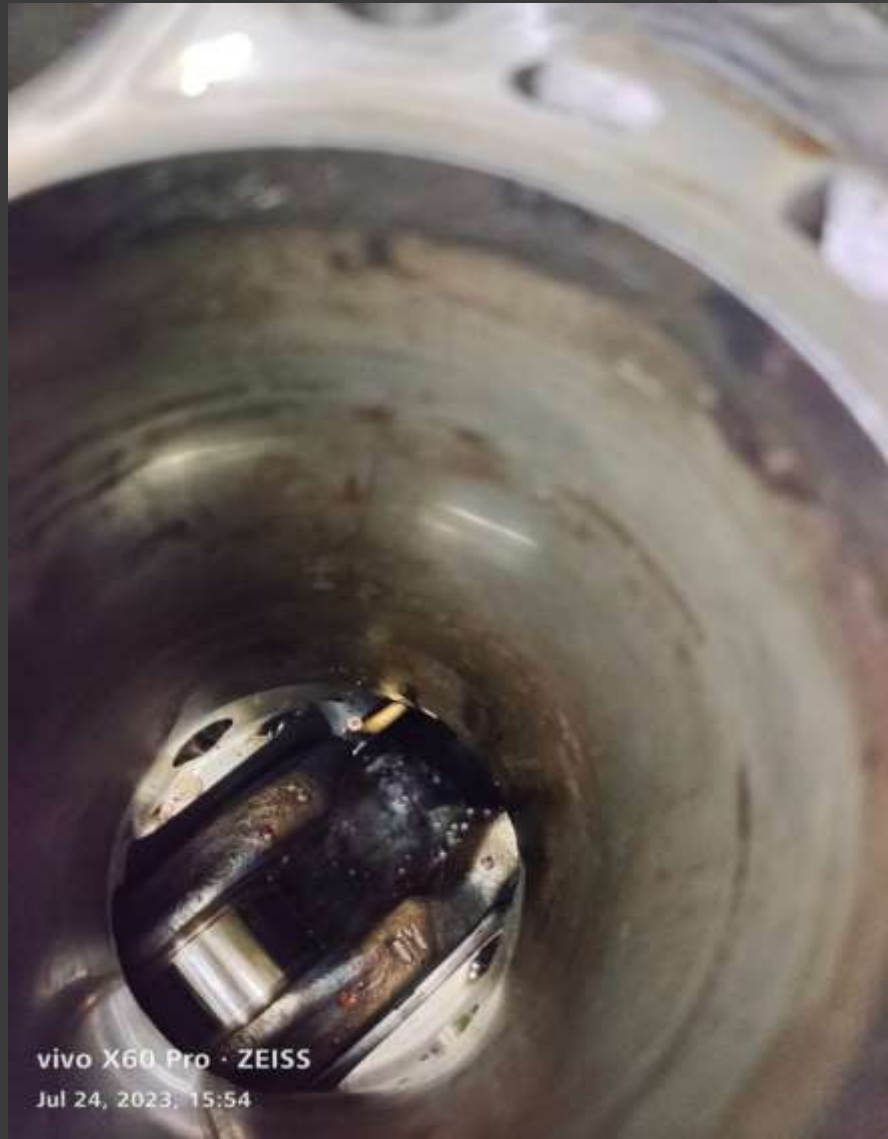
Extent of damage in case of Hydrostatic lock:

- Bend of connecting rods.
- Corrosion of injectors,
- Turbo charger blades damage and corrosion of impellor shaft
- Crank shaft may get affected due to force on shaft.
- Cylinder bore corrosion or Pitting due to water ingress
- Few of the manufacturers are providing special treatments to withstand the thermal factors.

- If Cylinder bore damaged and if it is not supplied as a child part, then the complete engine assembly requires replacement.
- For normal engines where there is no special treatments on cylinder walls, the engine block will not damage if we take quick action. For those, replacing of connecting rods, etc is enough. It depends on case to case basis
- Sometimes for manual transmission vehicles, if we try for push start after the hydro static lock, then the bent connecting rods breaks and damages the engine block.
- The extent of damage depends on the rpm of the engine / quantity of water entry.
- Some times, the engine will be in running condition after hydrostatic lock but producing white smoke..it means, the connecting rod is bend and improper fuel combustion is taking place. Engine needs to dismantle
