**VARIOUS TYPES OF ENGINE LOSSES
(PRIVATE CAR)**

MVSD PRASAD & A. SRINIVAS REDDY

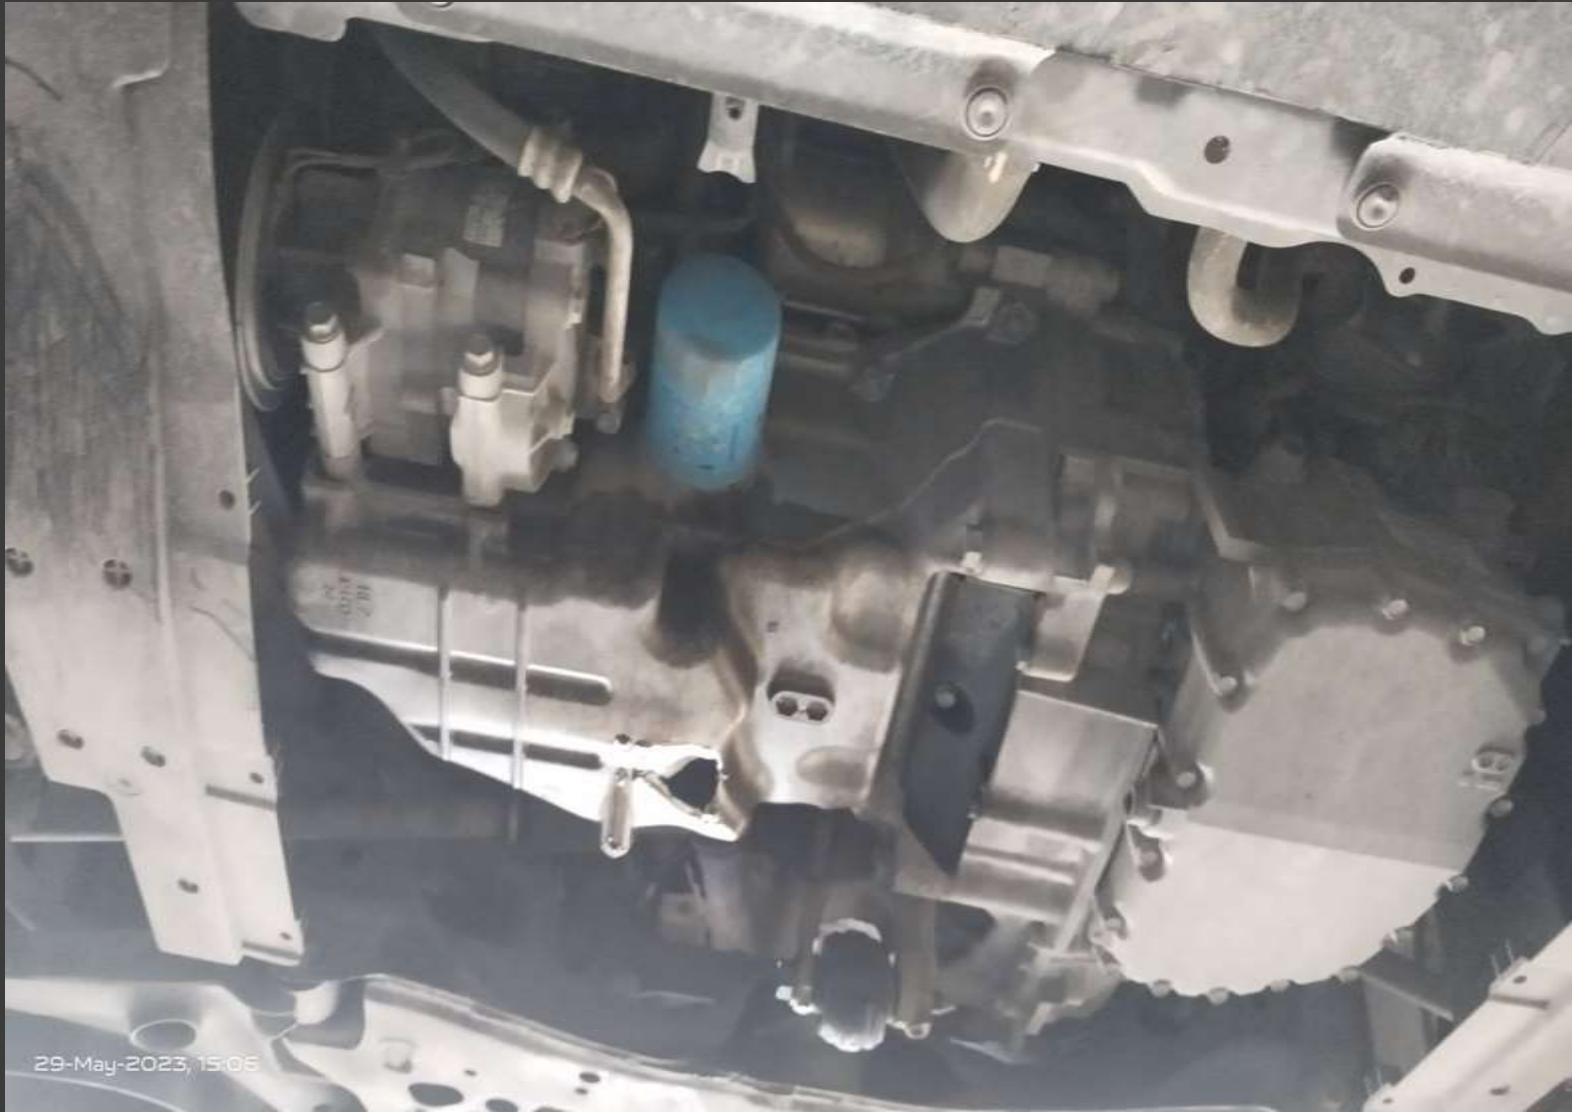
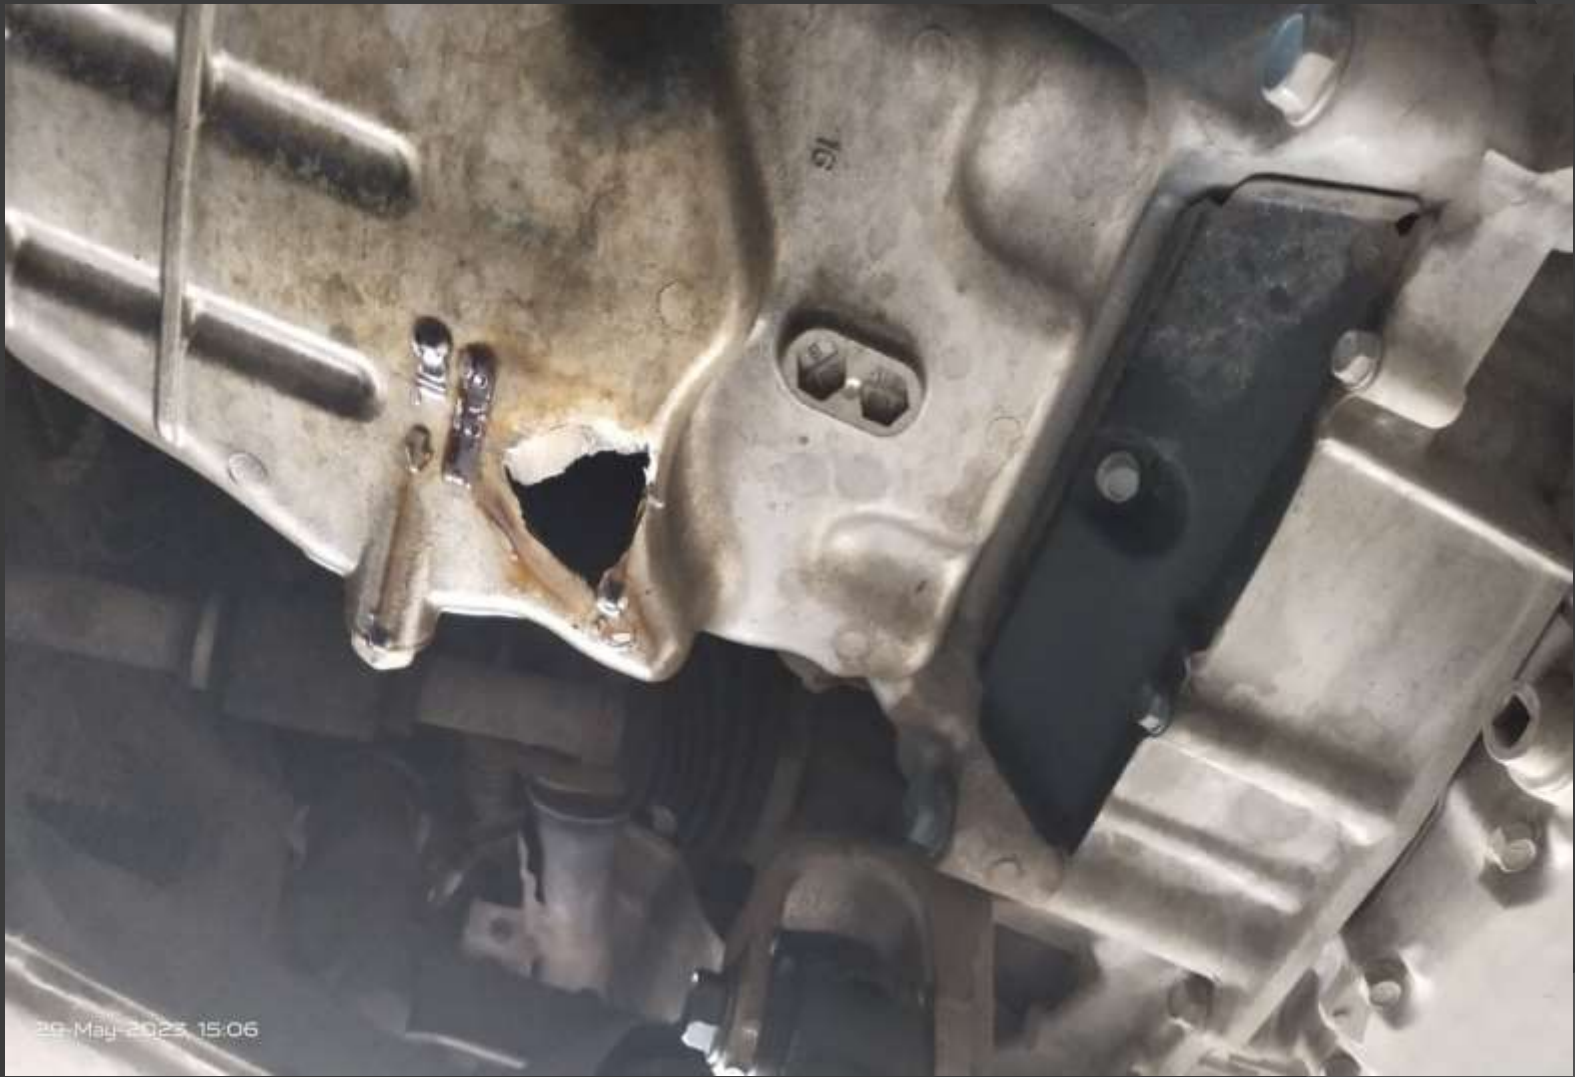
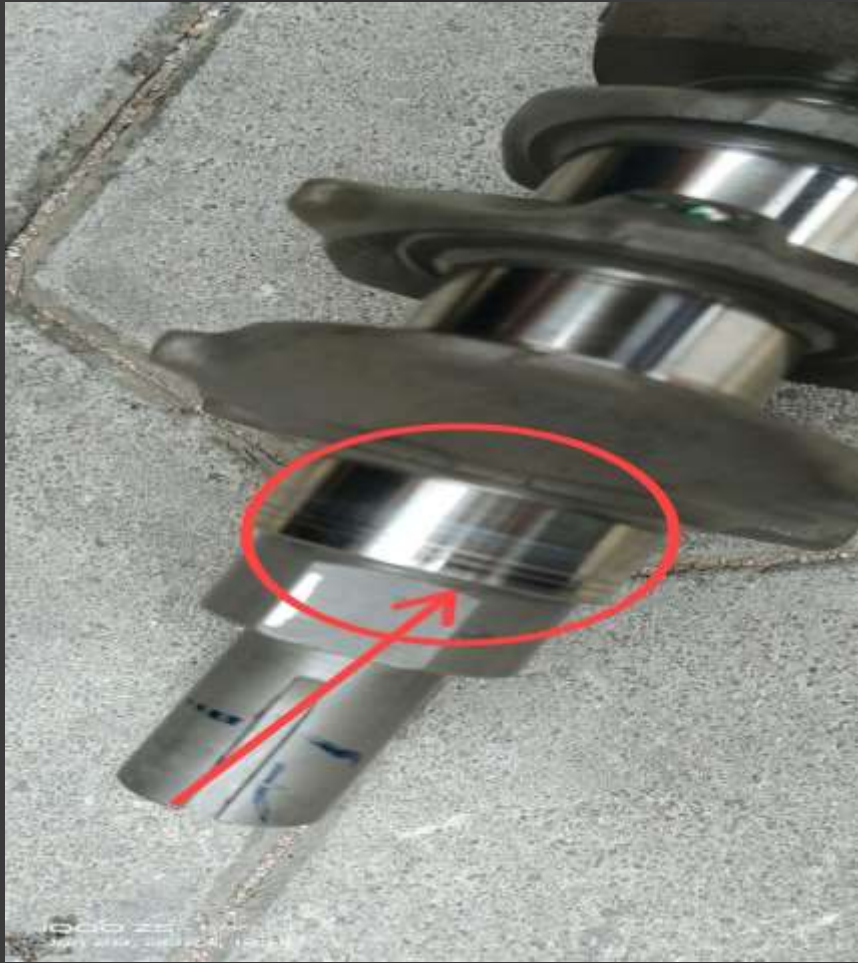
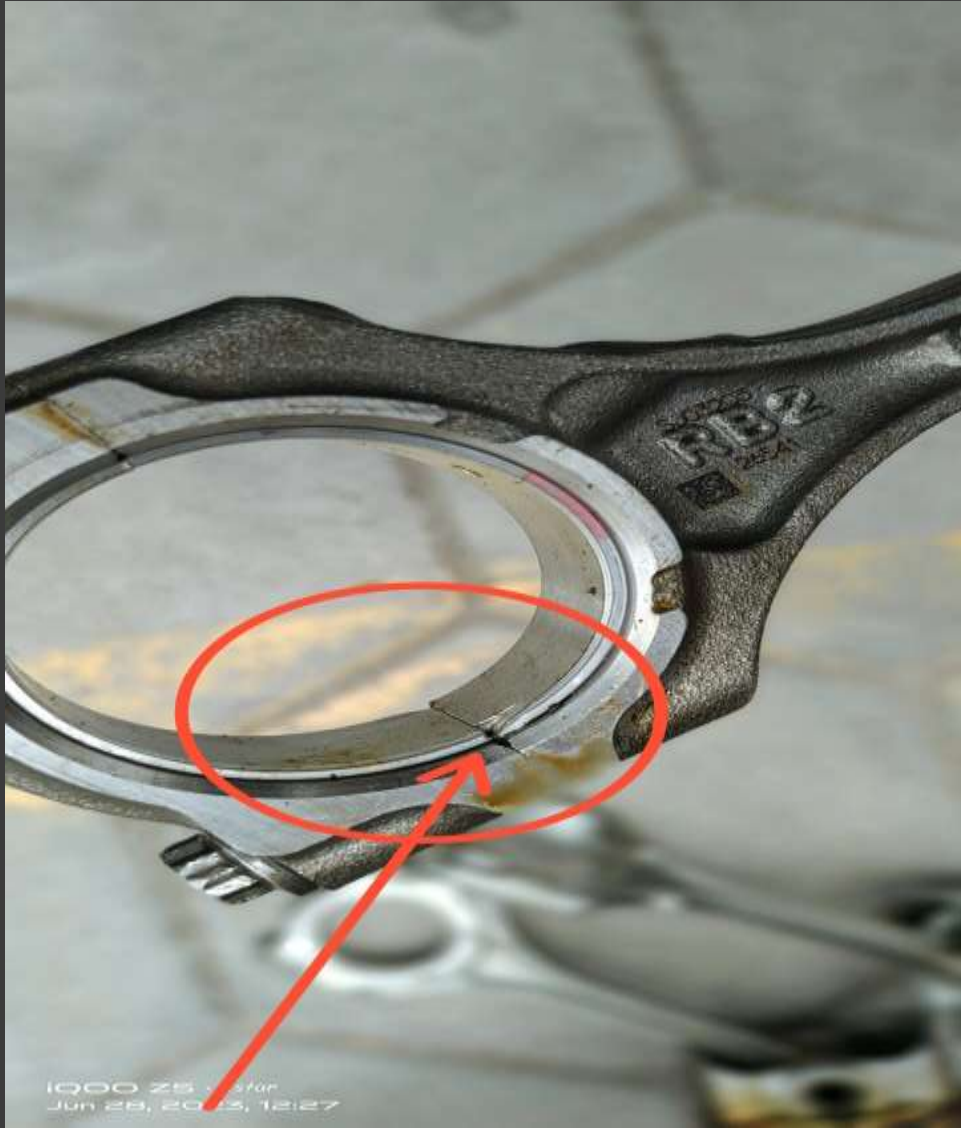
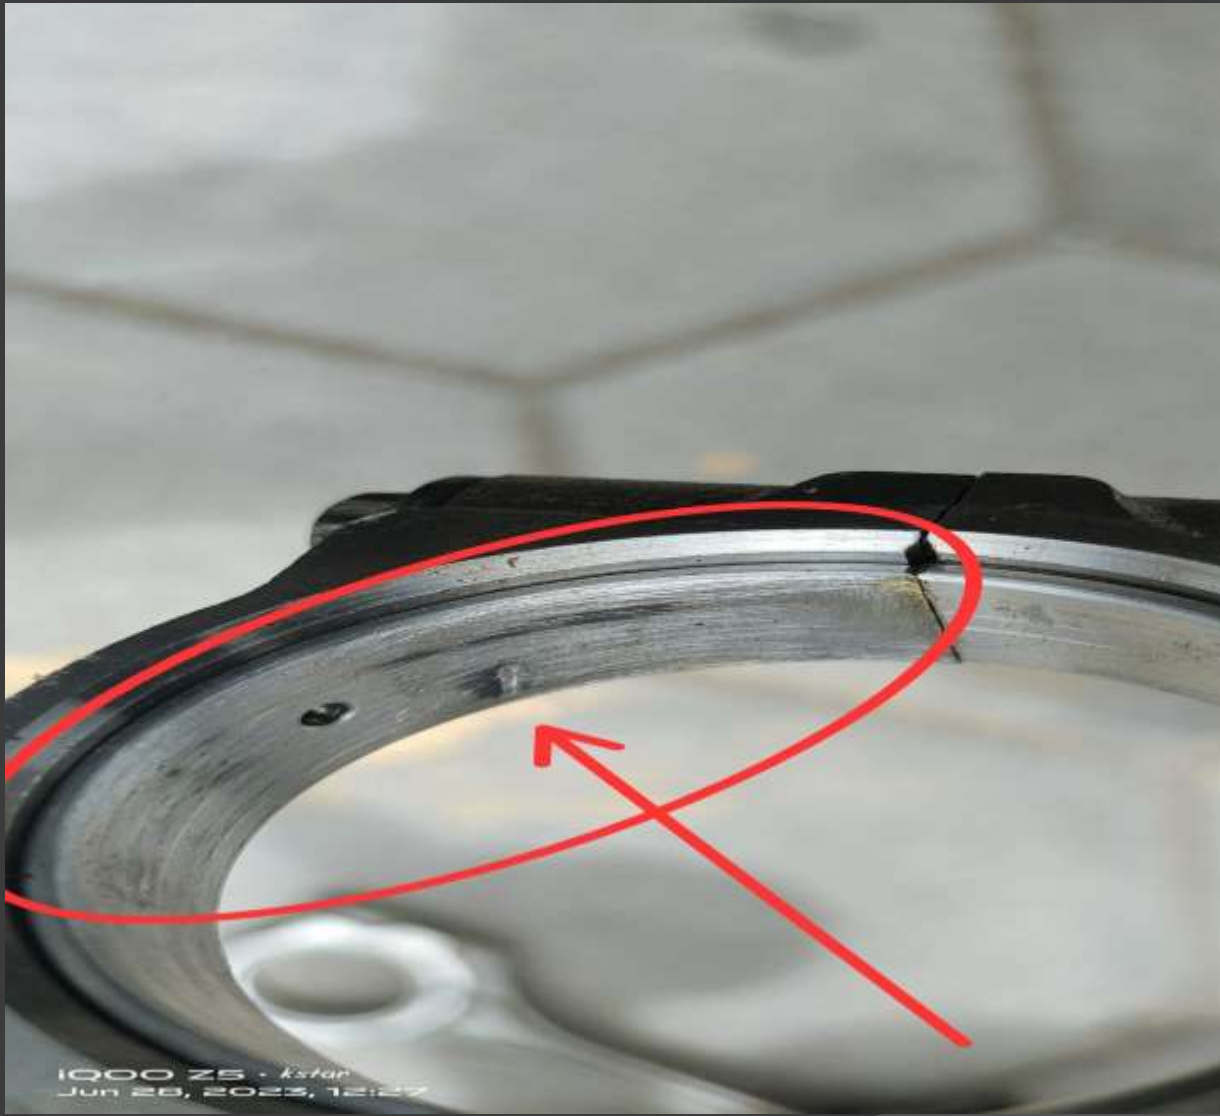
Engine loss due to Engine oil leakage

- ⦿ **Damage/ hole on the engine oil Pan due to external impact.**
- ⦿ **Impact on engine oil pan causes oil strainer broken cases**

Note : If the engine runs further in these conditions, the engine gets seized at crack shaft bearings due to lack of lubrication.

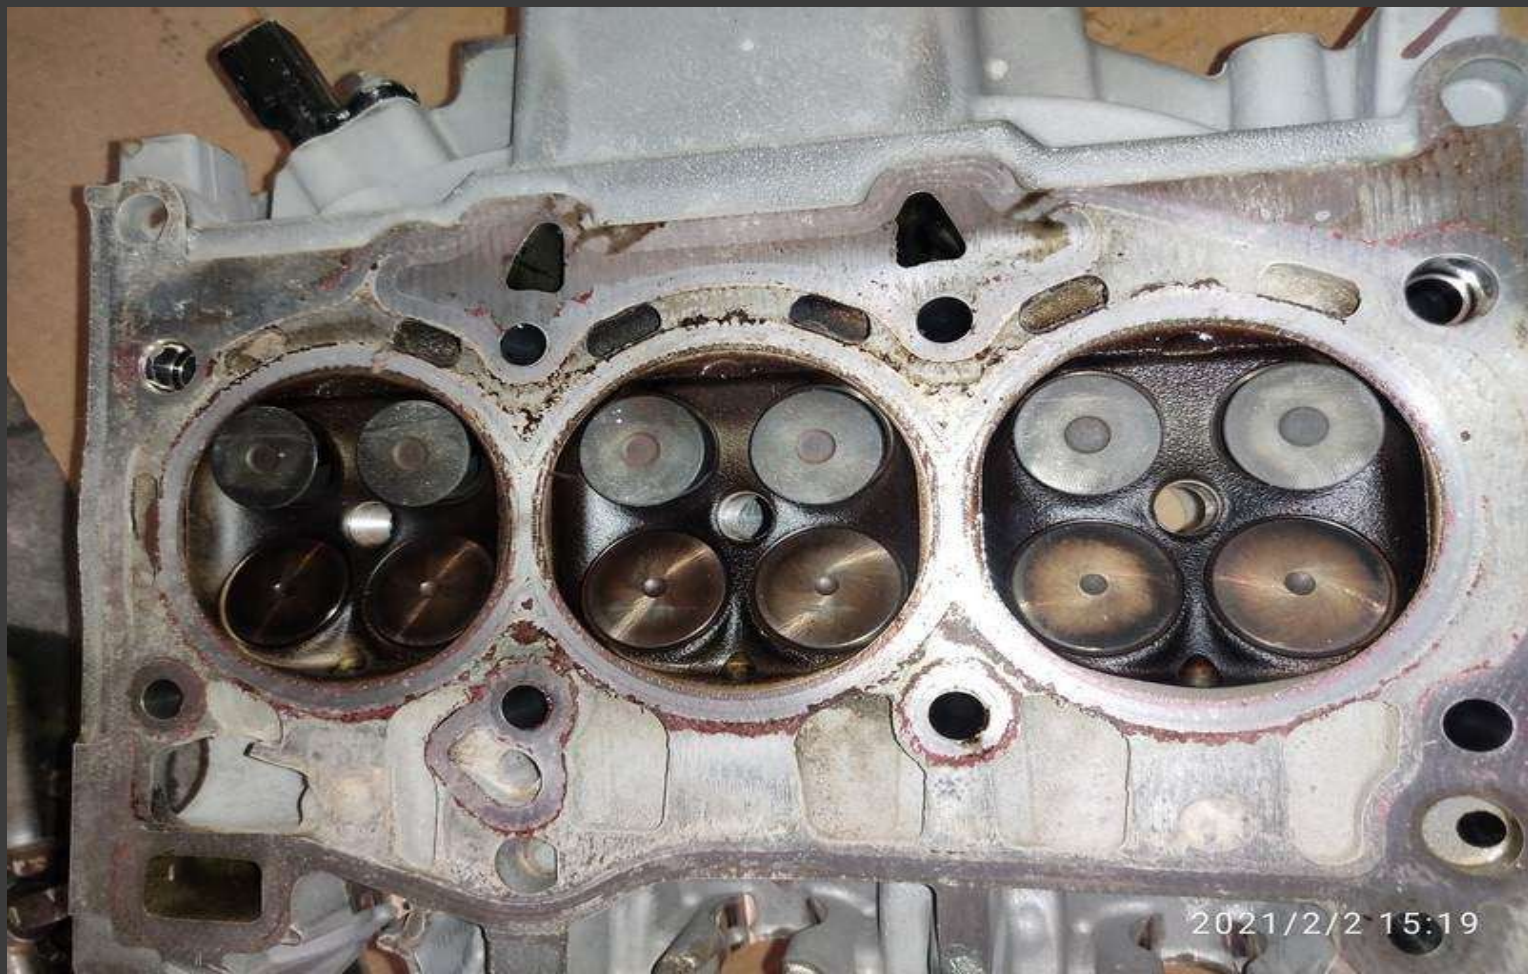
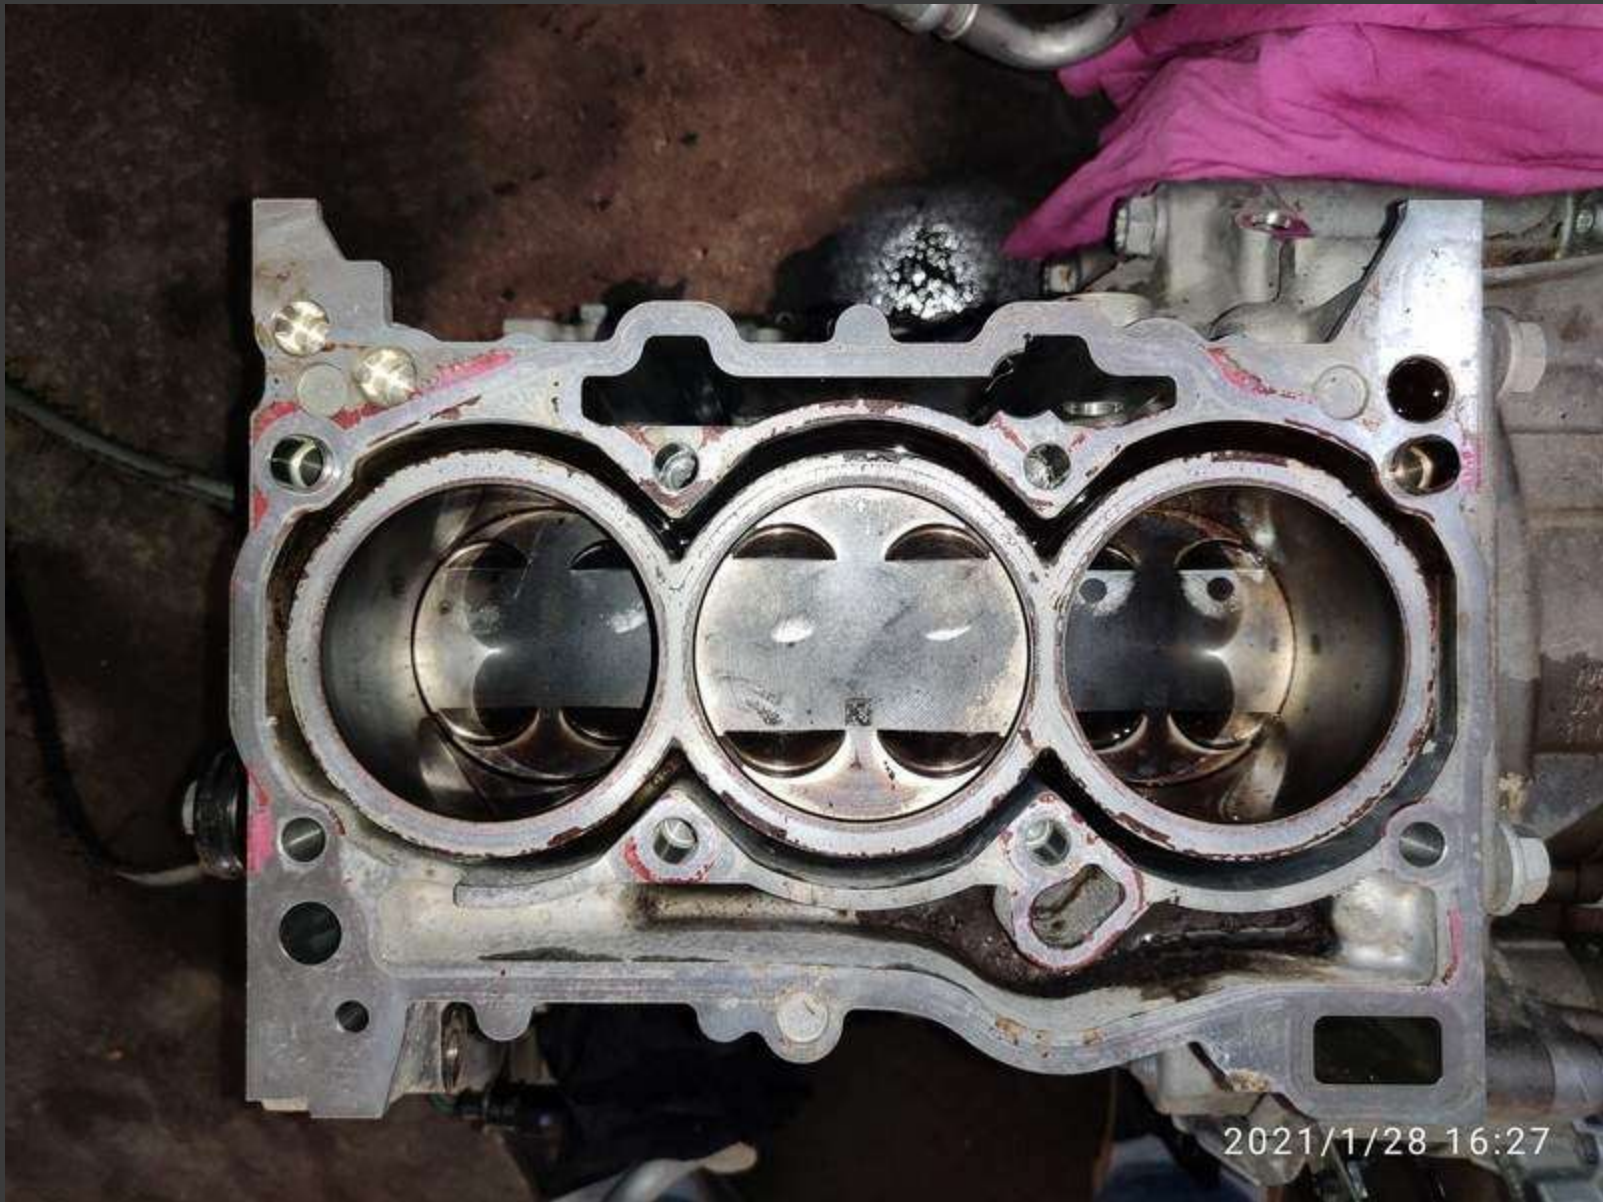
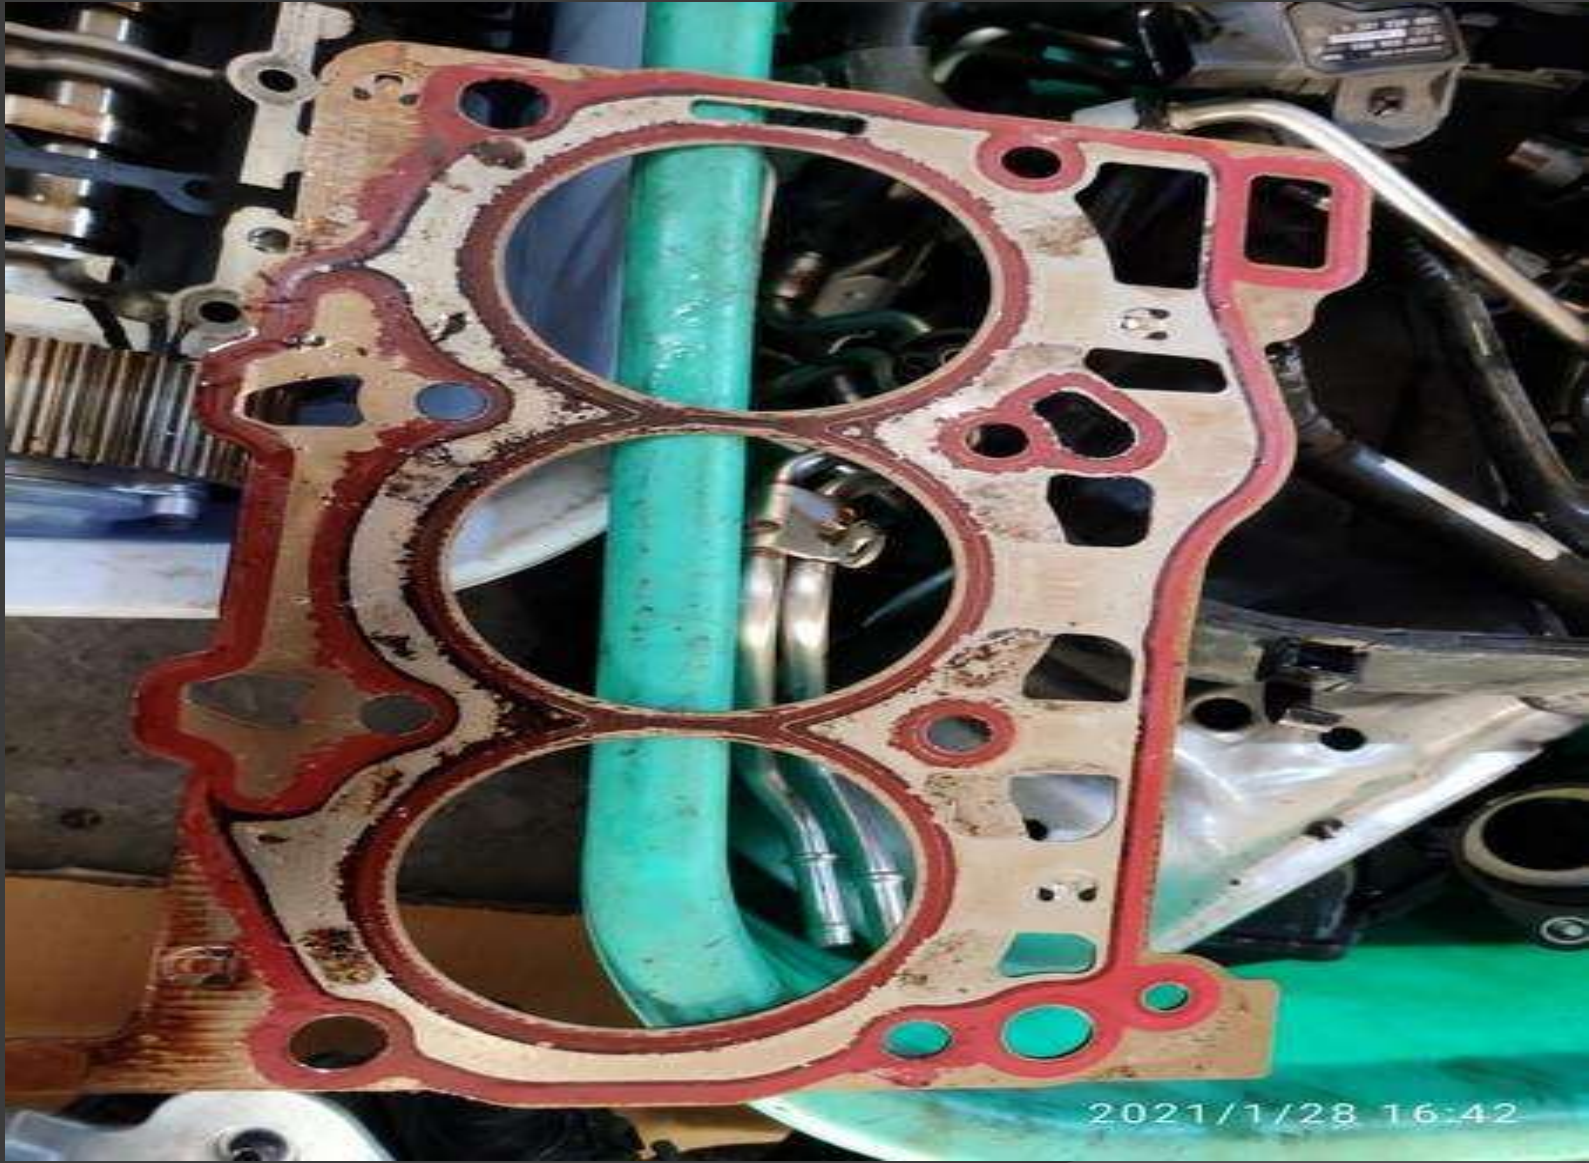
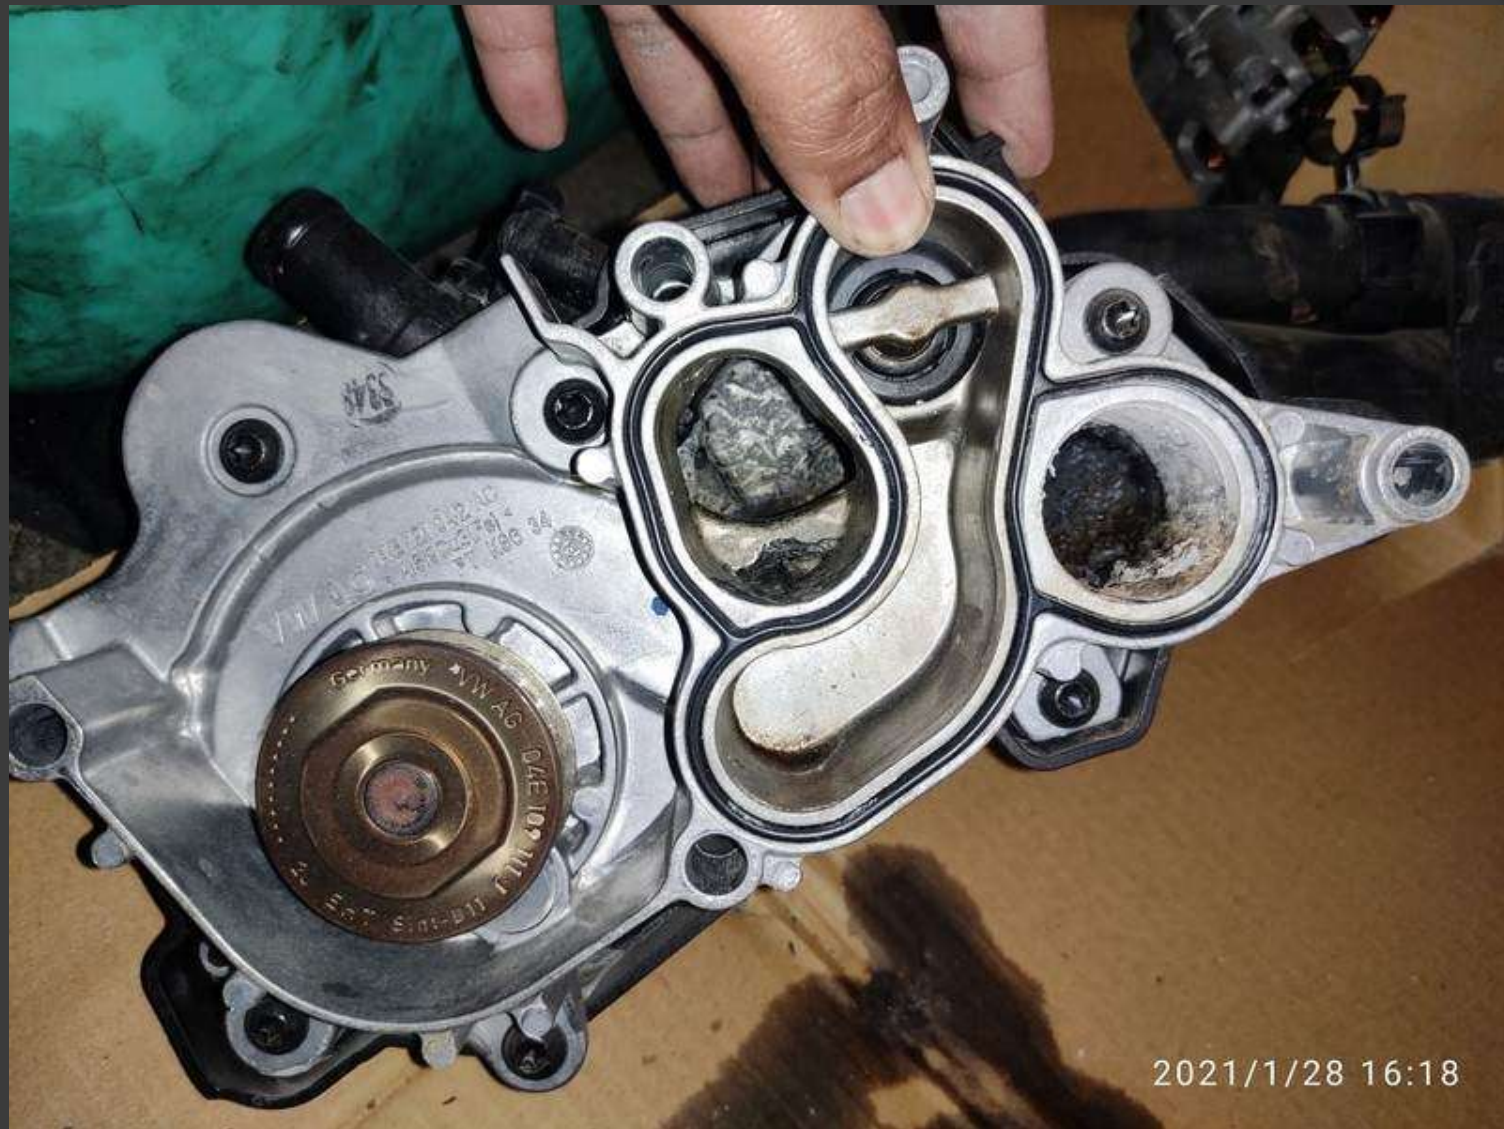
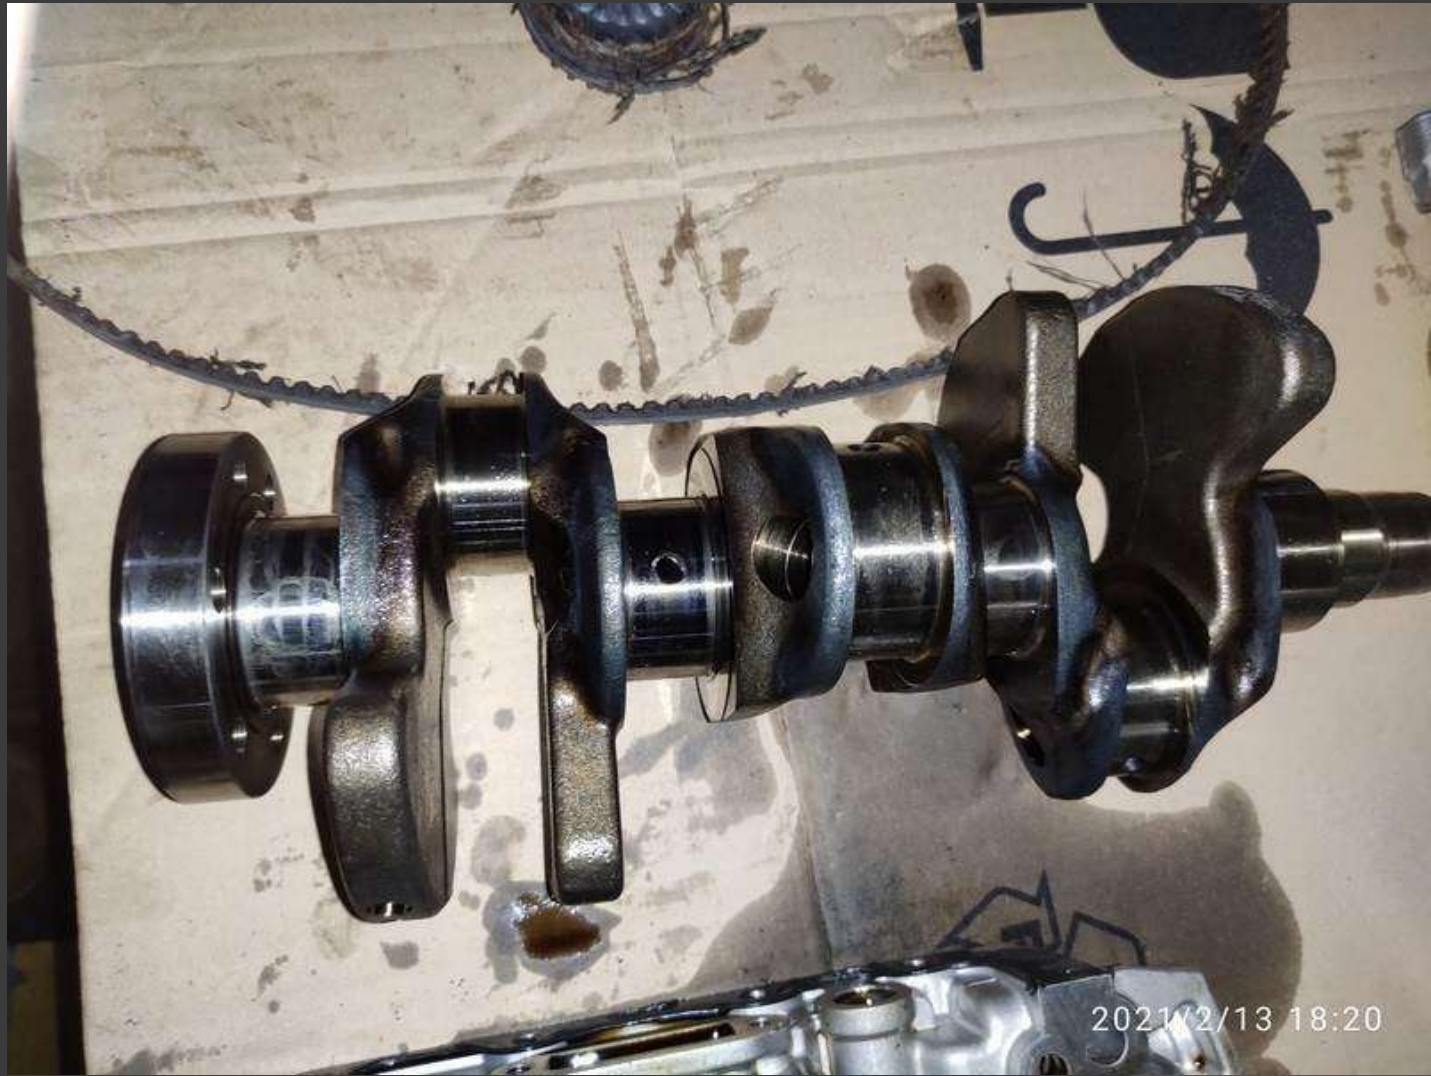
Head gasket and cylinder head mechanism damage

- Coolant loss due to external impact.

Note: Coolant helps pull heat away from the engine. So, without enough coolant, the engine could overheat or seize up. Continued use of an overheated engine could lead to permanent damage, such as pistons, cylinder walls, head.

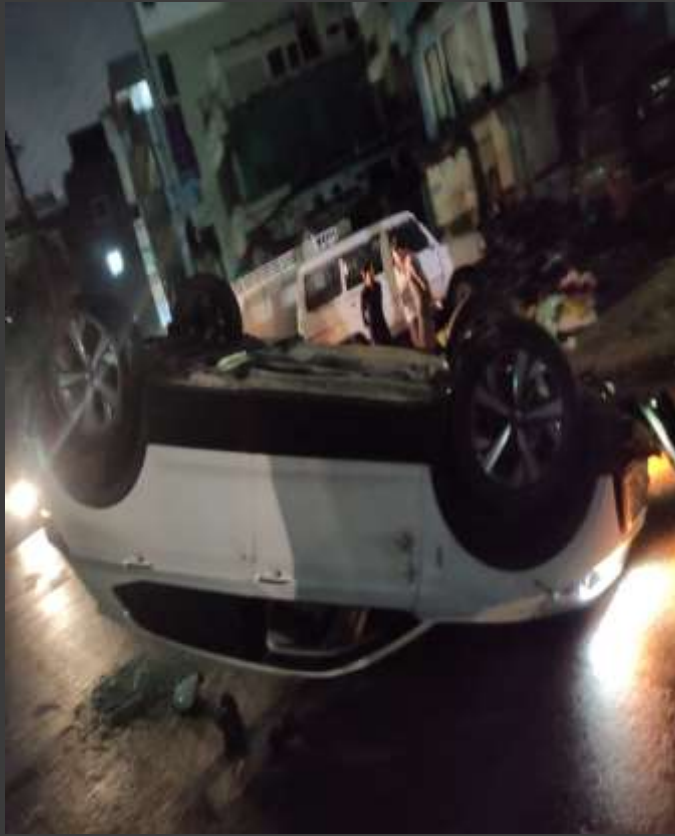
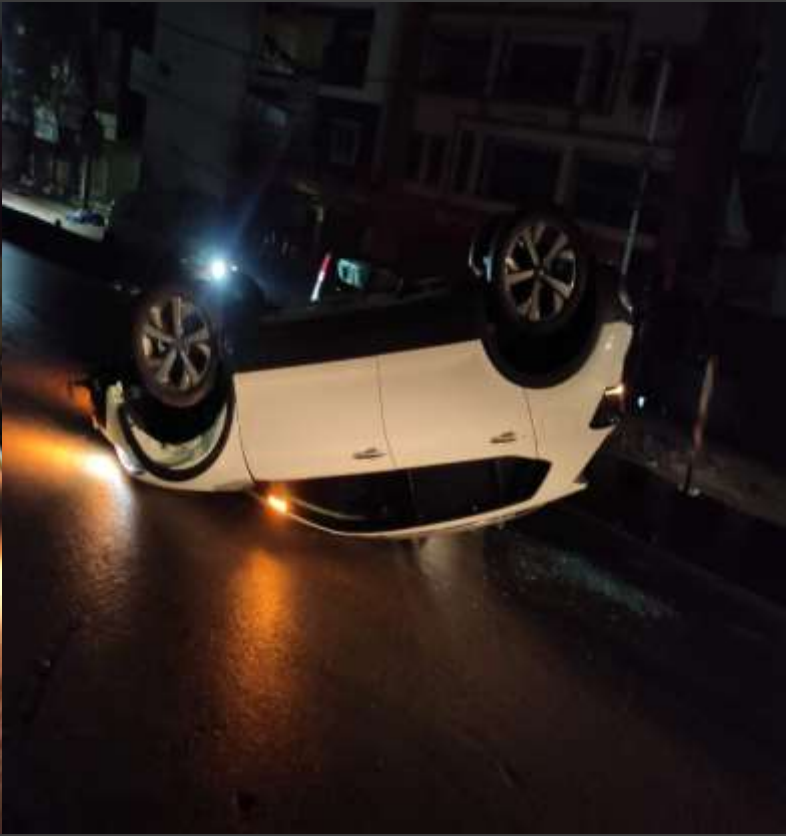
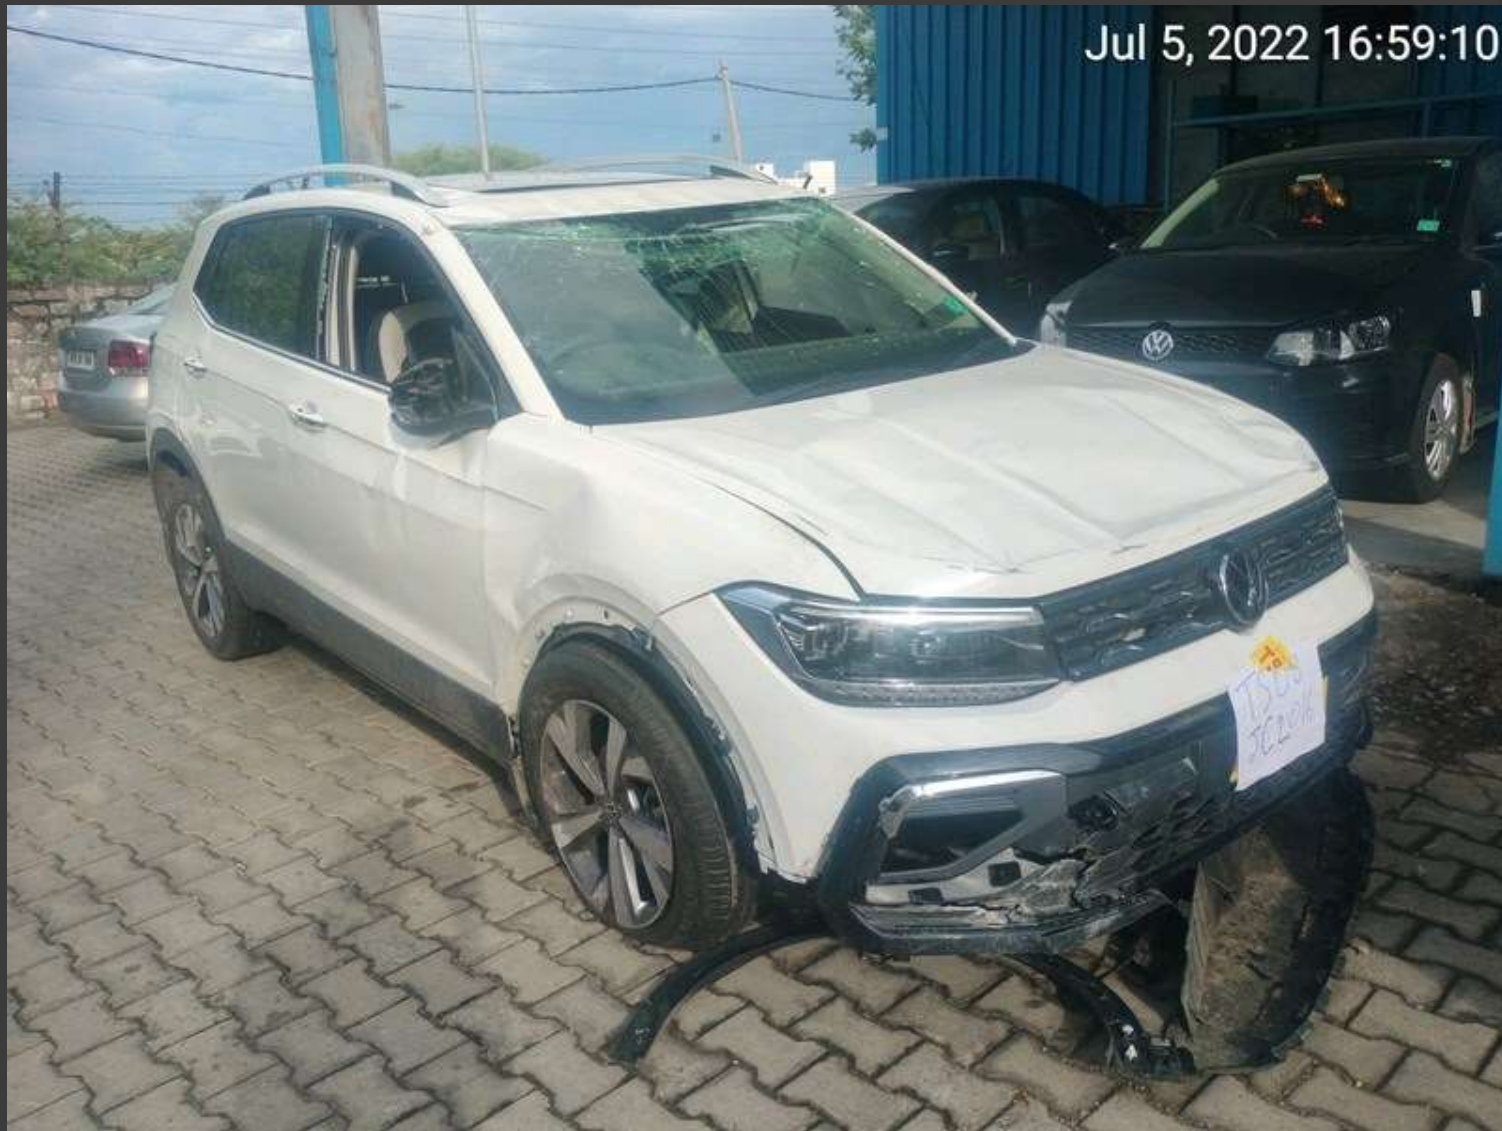
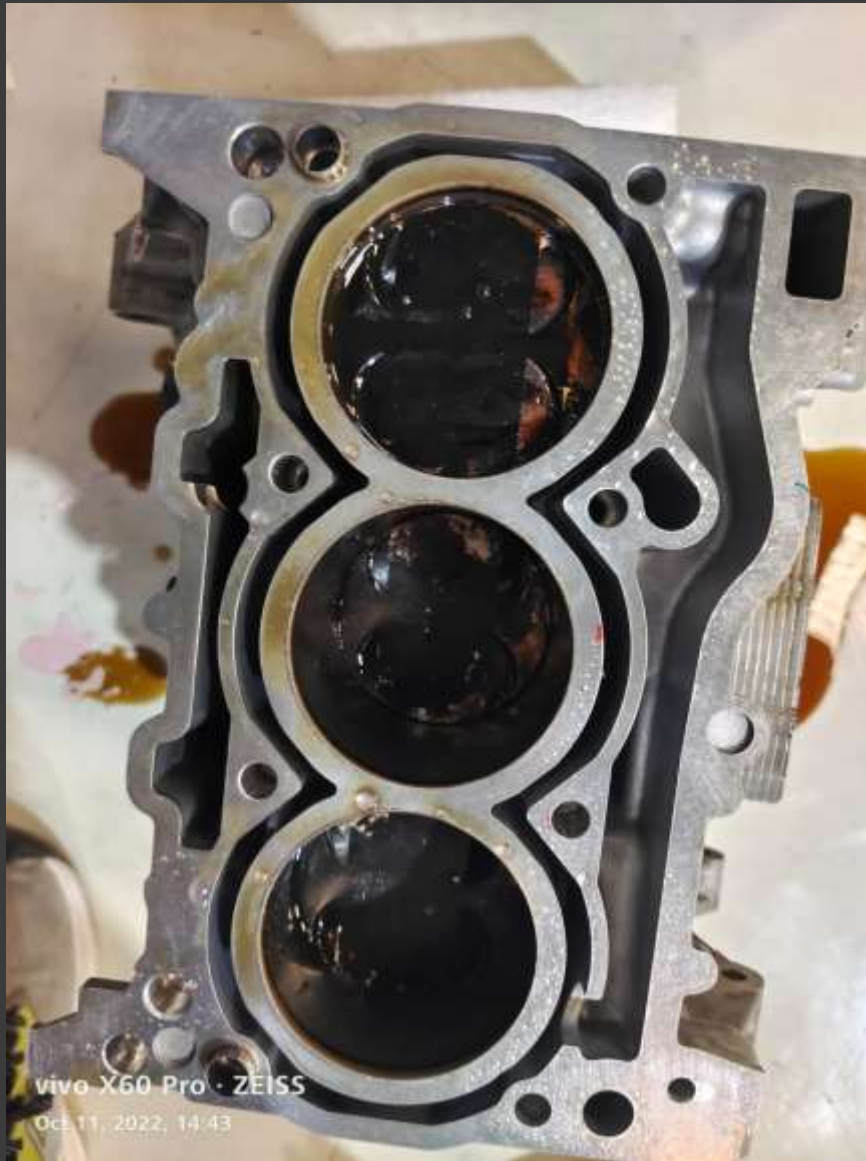
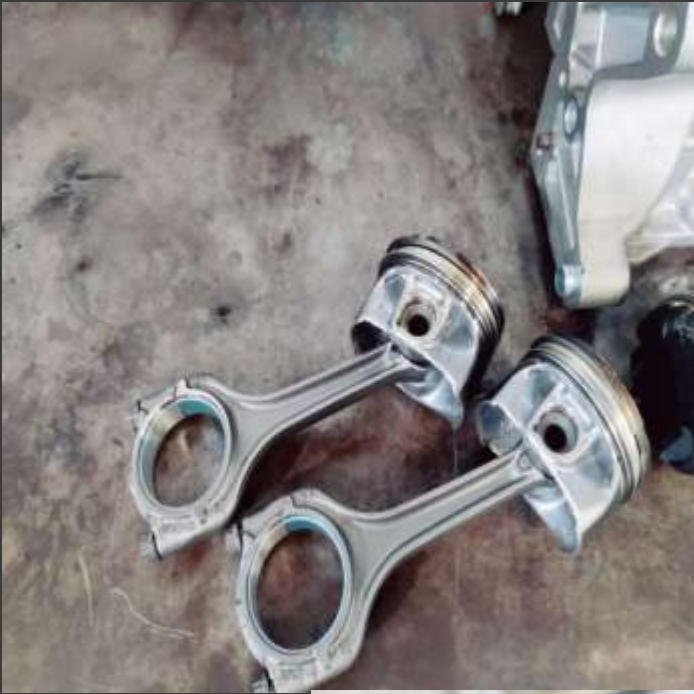
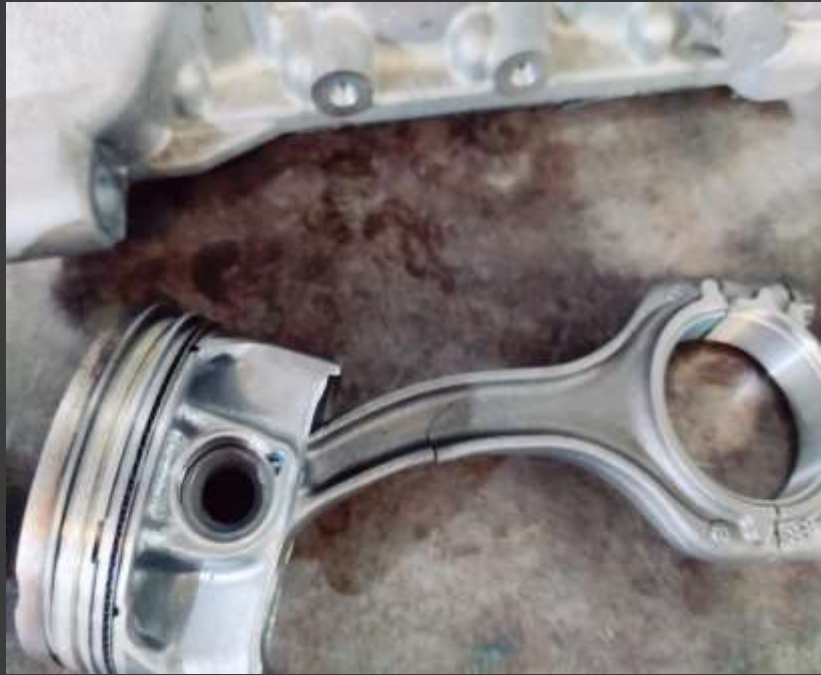
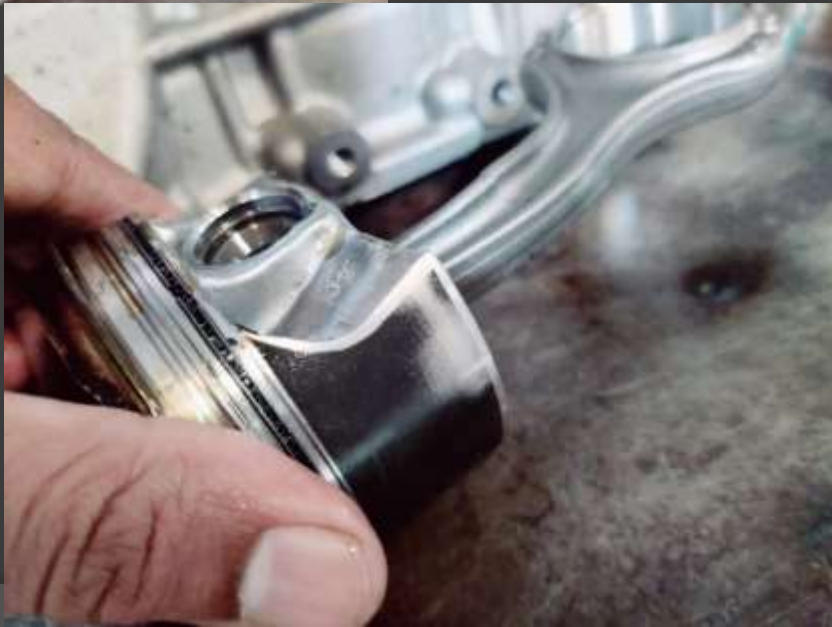
Vehicle rollover/ flipped Cases

- ⦿ An engine that has been flipped over may no longer have its fluids in the right places. Oil can work its way up into the top end of the engine. Brake fluid and power steering fluid is apt to leak, and automatic transmission fluid too.
- ⦿ If engine is in start condition, the engine oil will enter into combustion and that leads to damage.

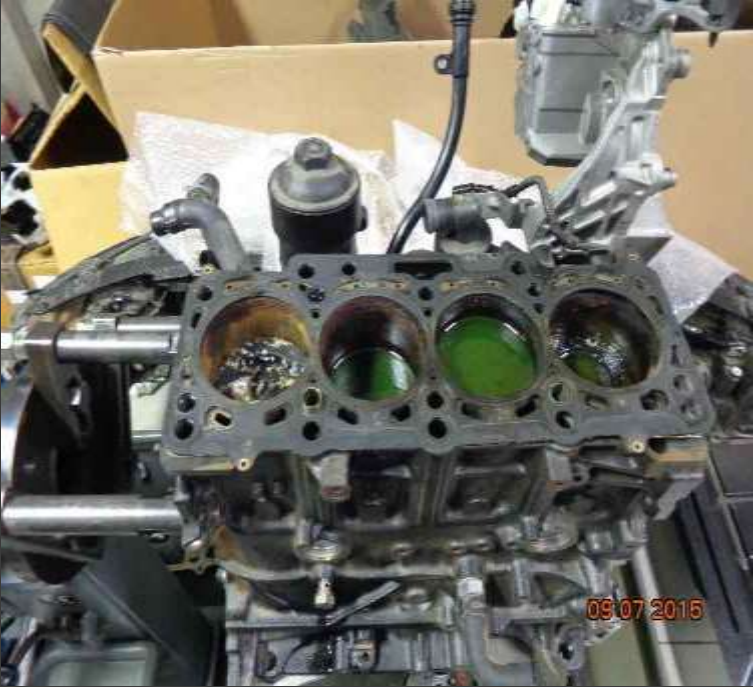
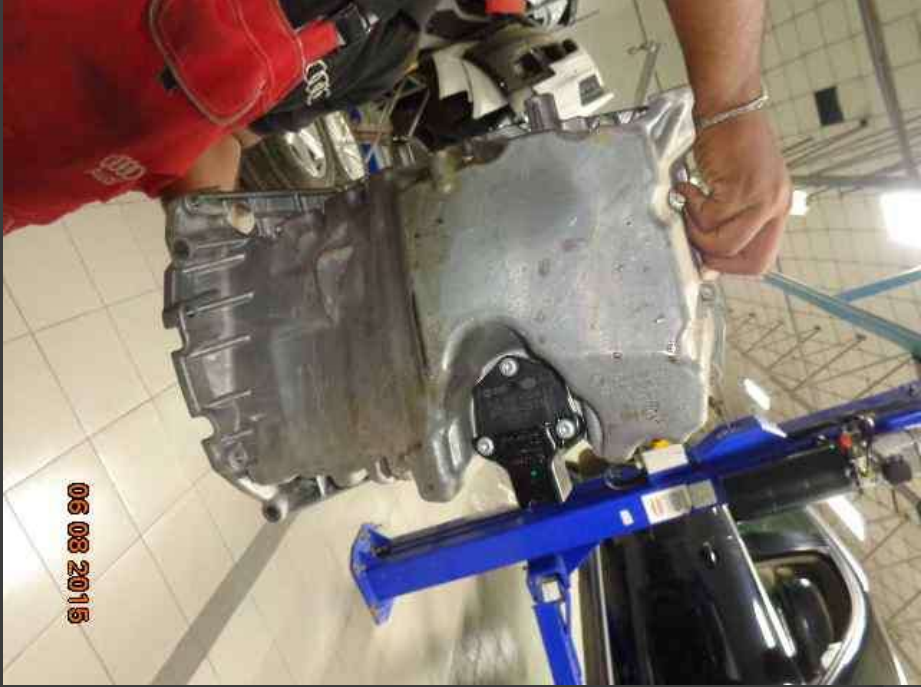
Colour of Audi coolant
