**VARIOUS TYPES OF ENGINE LOSSES
(PRIVATE CAR)**

MVSD PRASAD & A. SRINIVAS REDDY

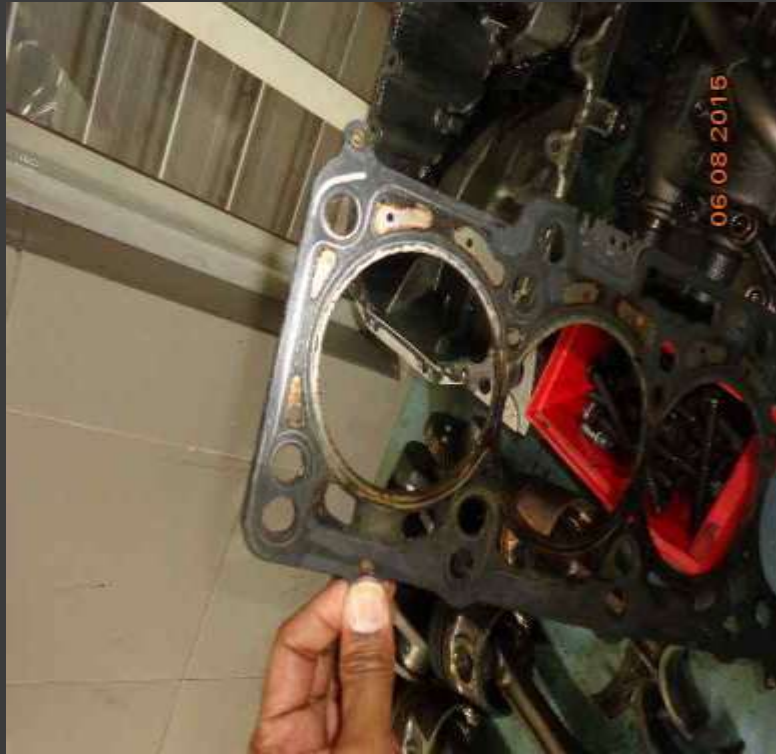
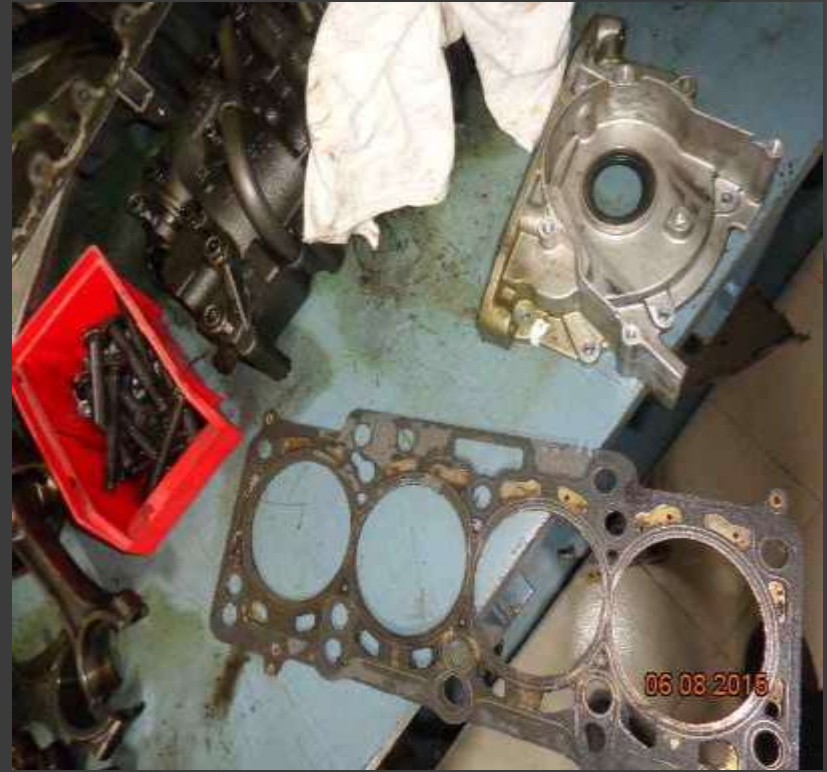
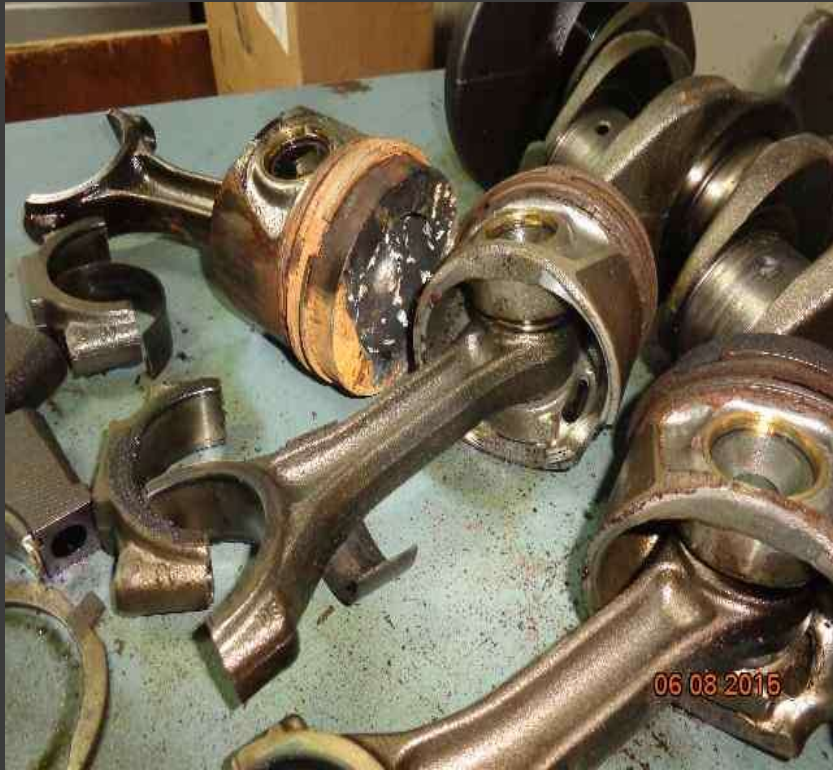
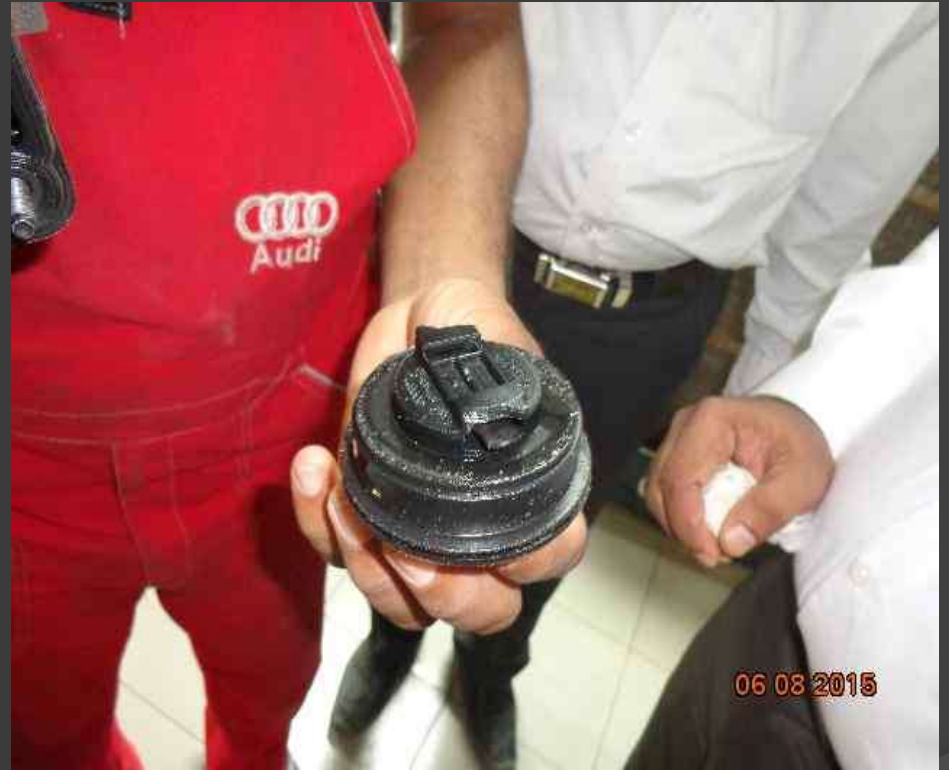
Case study....engine block

- Petrol engine....bent connecting rod tapped the edge of engine block
- We need to check the extent of damage
- How far it is located from BDC
- In few cases, the impact will not be up to BDC/no effect on the compression...we can use the same block if cylinders walls are fine.
